2014 Outlander

TECH TALK

Volume 194, February, 2013

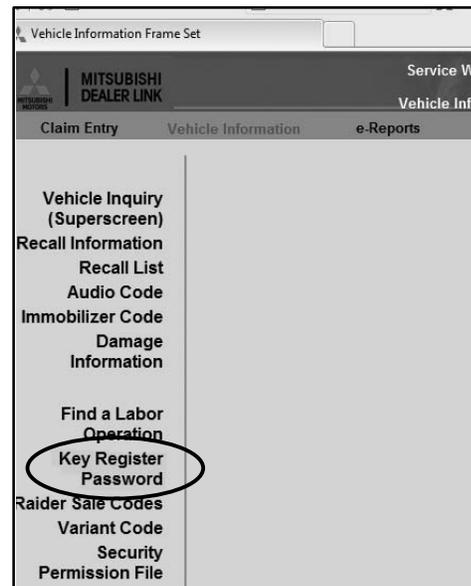
INCORRECT IMMOBILIZER PASSWORD ENTRY — All with immobilizer. When using the scan tool (MUT III) to register keys, if you incorrectly enter a key register password five times in a row, the immobilizer judges the system is operating incorrectly and immobilizes the engine. To overcome this condition, insert a cut key into the ignition switch, turn it to the ON position and leave it for approximately 20 minutes. You will then have 5 more attempts to register keys. Refer to the service manual for further immobilizer details.

Passwords can be found on the MDL by clicking service >> systems >> Vehicle Information >> Key Register Passwords.

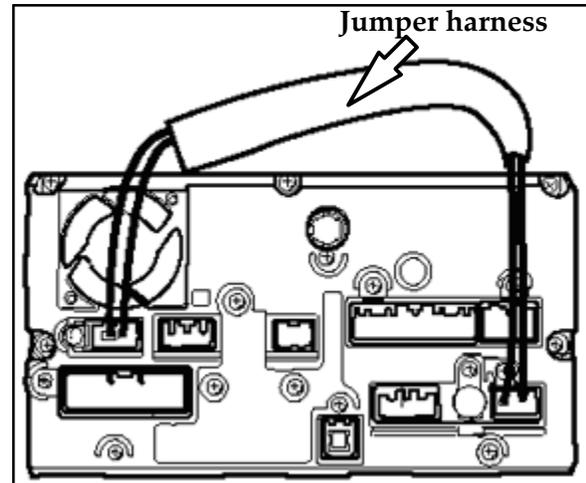
REAR VIEW CAMERA DISPLAY WHEN ACCESSORY NAVIGATION IS ADDED — 2007-13 Outlander, 2008-13 Lancer, Lancer Evolution, 2009-13 Lancer Sportback, 2011-13 (RVR) Outlander Sport. When authorized Mitsubishi accessory navigation is added, either at the port or by the dealer, to a vehicle with a rear view camera, the image will still appear in the

rear view mirror. The image is ONLY displayed on the navigation screen if it is factory installed.

Customers may report there being two sets of location lines in the display. Installation of an accessory navigation unit requires a jumper harness to eliminate the double line display. This harness is included with the navigation unit, NOT the installation kit. Refer to the installation instructions included with the kit and insure the jumper harness was installed.
