# TECH TALK

Volume 197, May, 2013

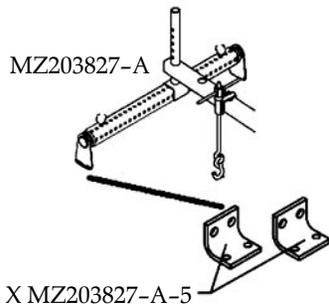
Remove 2 X MZ203827-A-5

- To prevent damage to the engine compartment, remove the two foot attachments (MZ203827-A-5) from MZ203827-A. Make sure the rubber coatings of the feet are not damaged or missing to prevent the support damaging the engine compartment.

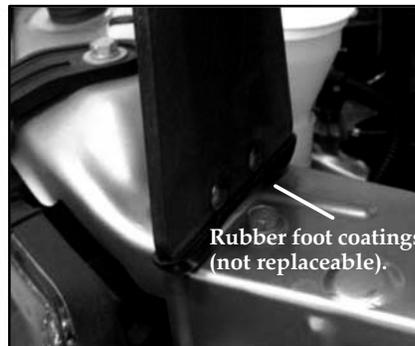
- While installing MZ203827-A, adjust the support bar so the feet rest above the two radiator upright supports (passenger side shown, driver's side similar).
- Ensure the two rubber foot covers (MZ203827-B-1) from MB203827-B are properly installed and the feet of MZ203827-01 are securely placed on top of both strut towers.
