Technical Service Bulletin

SUBJECT:			No:	TSB-13-11-001
OIL PUMP CHAIN GUIDE ELIMINATED – SERVICE MANUAL REVISION			DATE:	January, 2013
			MODE	L: See below
CIRCULATE TO:	[] GENERAL MANAGER	[X] PARTS MANAGER		[X]TECHNICIAN
[X] SERVICE ADVISOR	[X] SERVICE MANAGER	[X] WARRANTY PROCESSOR		[] SALES MANAGER

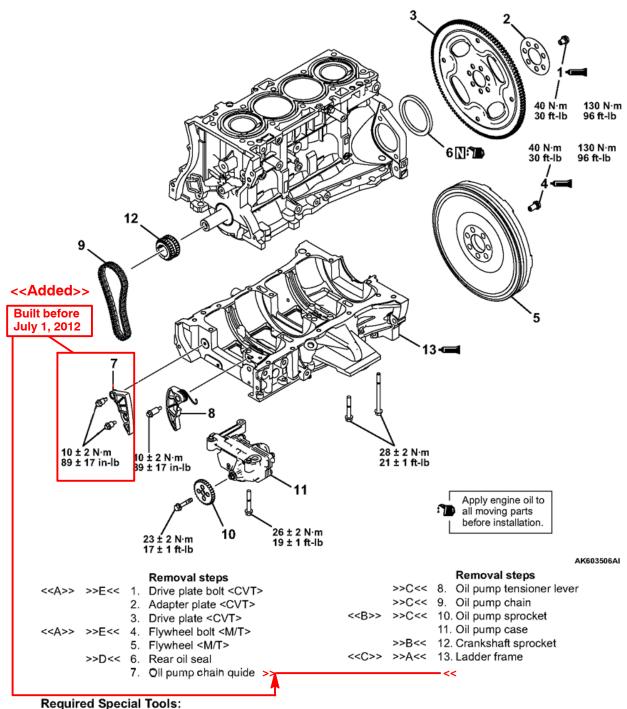
The oil pump chain guide was eliminated in 2.0 liter (4B11) non-turbo engines effective with July 1, 2012 production. This TSB provides updated service manual information.

Make the indicated changes to:
