*** * TECHNICAL INFORMATION NOTICE * ***

DATE: February 1, 2013
TO: Mitsubishi Motors Parts Managers
Mitsubishi Motors Service Managers
RE: 2013 Outlander Sport /RVR TPMS Sensor - Temporary Production (REVISED)
TIN NO. TIN-13-42A-001

AFFECTED VEHICLES: Certain 2013 Outlander Sport/RVR

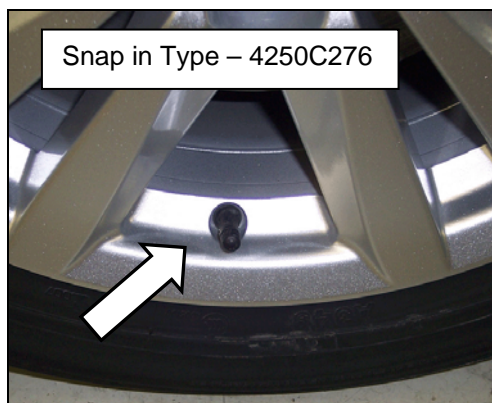
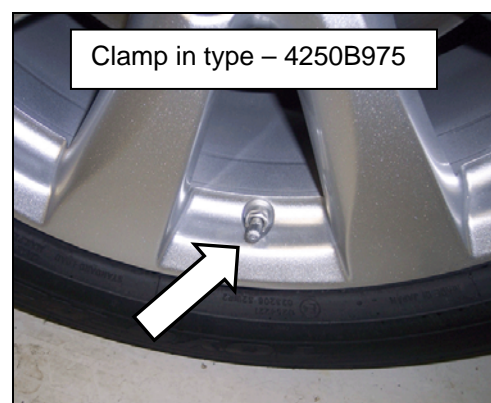
Due to a supply issue with the “snap-in” type Tire Pressure Monitoring System (TPMS) sensor, subject vehicles are temporarily being built using the 2012 “clamp in” type sensor. This change will affect production and service parts until the supply issue is resolved. An owner’s manual addendum card reflecting this change has been placed in the glove box of affected vehicles.

The TPMS sensor type can be easily identified by the valve stem.

This change will result in p/n 4250C276 being temporarily superseded to p/n 4250B975 in the service parts system. Once p/n 4250C276 becomes available, the supersession will be broken, allowing supply of both part numbers. If a replacement sensor is required, install p/n 4250B975. If a customer comments about the cosmetic difference, advise them the original specification sensor can be installed, at no cost to them, when inventory becomes available.
