Mitsubishi Motors North America, Inc.

PARTS BULLETIN

**2013 OUTLANDER SPORT TPMS SENSOR –
TEMPORARY PRODUCTION
-- TIN-13-42A-001 --**

No: 54 – UT – 01 – 11

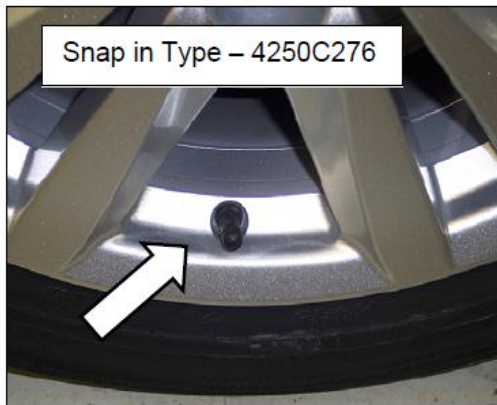
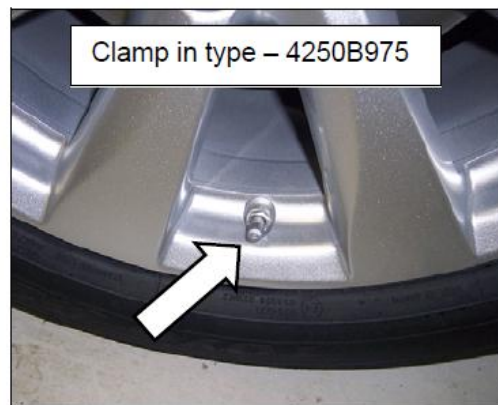
Due to a supply issue with the “snap-in” type Tire Pressure Monitoring System (TPMS) sensor, subject vehicles are temporarily being built using the 2012 “clamp in” type sensor. This change will affect production and service parts until the supply issue is resolved. An owner’s manual addendum card reflecting this change has been placed in the glove box of affected vehicles.

The TPMS sensor type can be easily identified by the valve stem.

This change will result in p/n 4250C276 being temporarily superseded to p/n 4250B975 in the service parts system. Once p/n 4250C276 becomes available, the supersession will be broken, allowing supply of both part numbers. If a replacement sensor is required, install p/n 4250B975. If a customer comments about the cosmetic difference, advise them the original specification sensor can be installed, at no cost to them, when inventory becomes available.
