## SERVICE INFORMATION BULLETIN

**TITLE :** Rear lamps water presence

**DOCUMENT # :** 12 A 002

**AFFECTED VEHICLES :** McLaren P1™

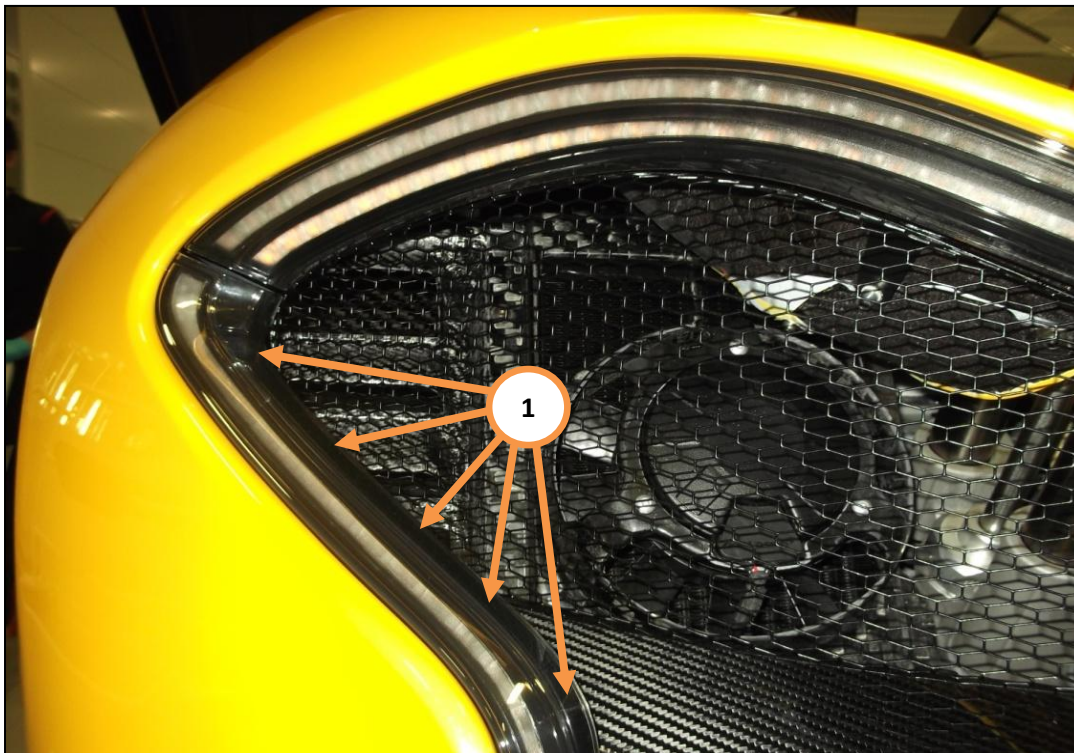
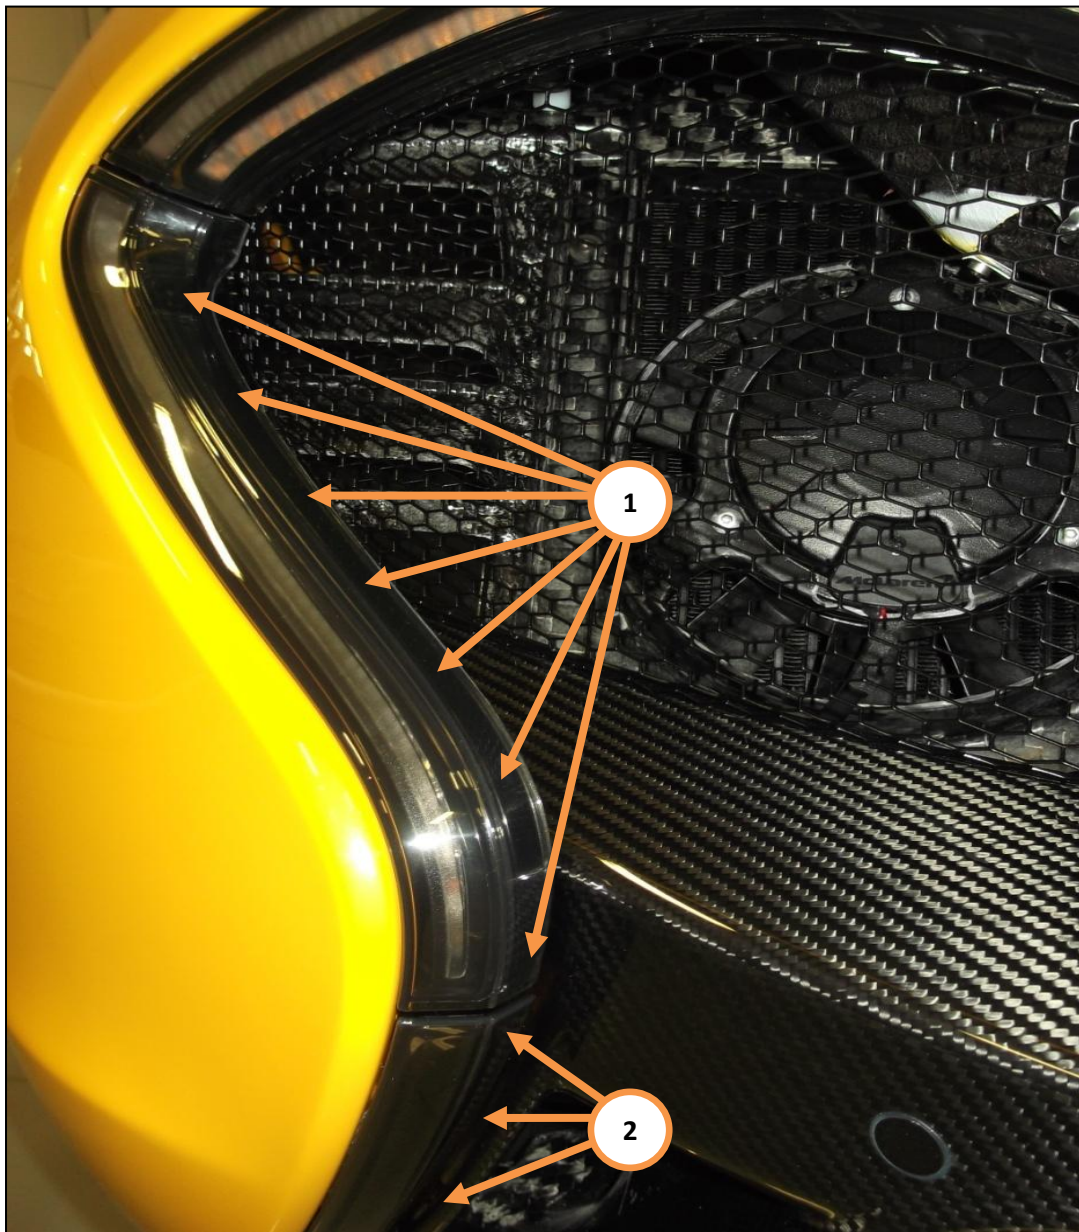
**SITUATION :** Quality Engineering at McLaren Automotive have highlighted that the design of the rear lamps, lower and dummy, is such that the inboard area of the outer lens is open to the environment and is not covered by any panel work. This means that there is a potential risk of water get trapped under that area when the vehicle is washed which could get misinterpreted as a failed lamp, when the lamp is perfectly fine.

If there is a customer concern for water ingress in the inboard area of the lamp, lower (1) and/or dummy (2), please explain to the customer that water can get trapped in this area due to the design of the lamp. The water will not affect the function of the lamp so there is no need to replace the lamp for this concern.

To remove the water temporarily it is recommended to gently blow the water off using compressed air. Otherwise, the water will eventually evaporate after some time.
