SERVICE INFORMATION BULLETIN

TITLE : Service Disconnect Cover Seal Replacement

DOCUMENT # : 12 N 001

AFFECTED VEHICLES : McLaren P1™

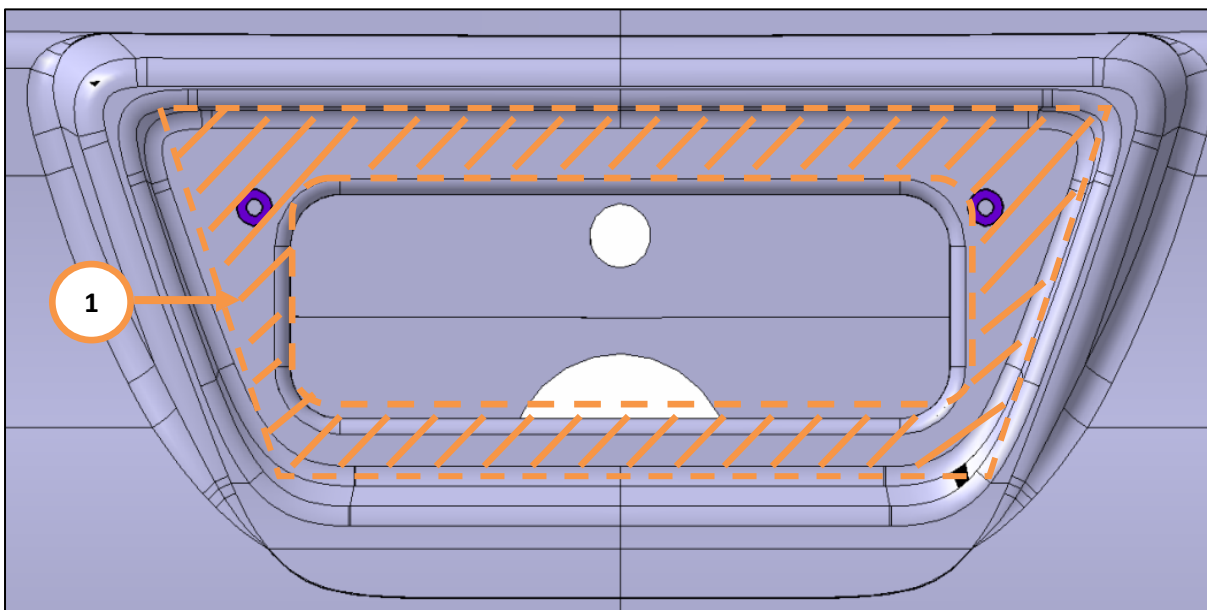
SITUATION : Quality Engineering at McLaren Automotive have identified the importance for the Service Disconnect cover seal to be replaced if the seal is damaged, worn or coming adrift in case the cover has been removed for a reason. As the fitment of this seal is quite crucial to its performance, a template is supplied to support in the fitment.

1. With the use of Betaclean 3900 (or similar isopropyl alcohol product) clean the highlighted mounting surface (1), where the tape will bond, ensuring the surface is dry and free of dust, oil and other impurities.

2. Apply adhesion promoter 3M 4298UV to the mounting surface (1) and allow 15 minutes before fitting the tape.
