SERVICE CAMPAIGN BULLETIN

CAMPAIGN REF: 022
TITLE : Subframe Bolt Check
DOCUMENT # : 11 A 037

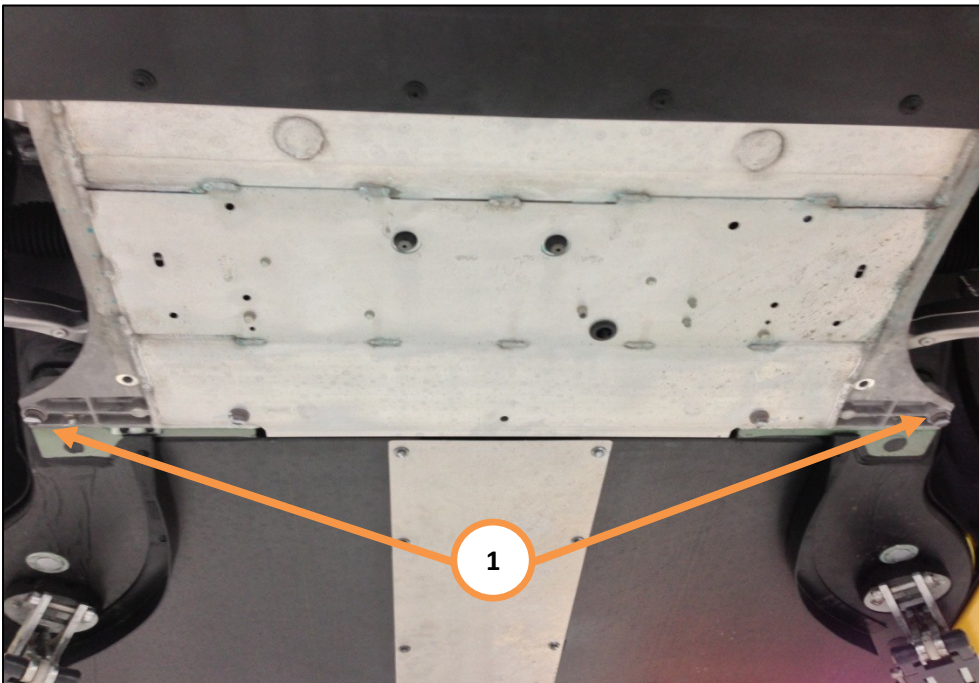
1. Please refer to AA-RM-02A04-04-007 Lift vehicle on lifting platform.
2. Locate the two rear outer bolts for the front subframe (1)

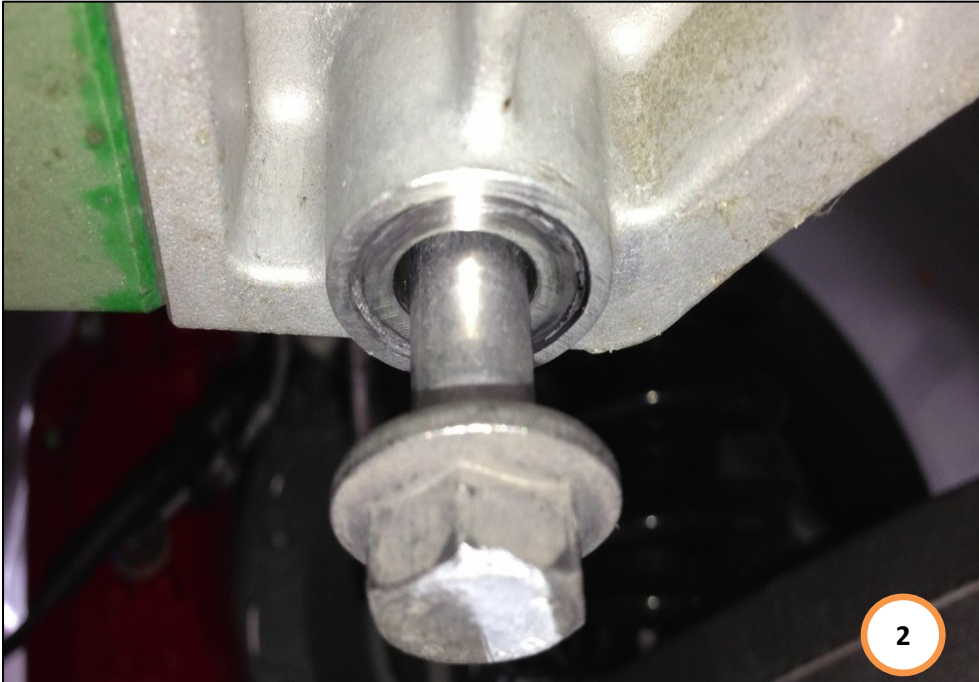
3. Torque check the bolts (1) by setting the torque wrench to 50Nm and check to see if the bolt turns. If it does not turn then repeat the process setting the torque wrench to 55Nm. Continue to repeat this process increasing the torque value by 5Nm until you have reached 70Nm. Should the bolt turn at any point before reaching 70Nm stop and proceed to step #4. If 70Nm is reached please continue with the remaining checks described in this document. The Results of these checks must be communicated to McLaren Technical Support.
4. Loosen both bolts (1) so they are protruding by 15mm and take a picture to show the positioning of bolt in the hole (2).

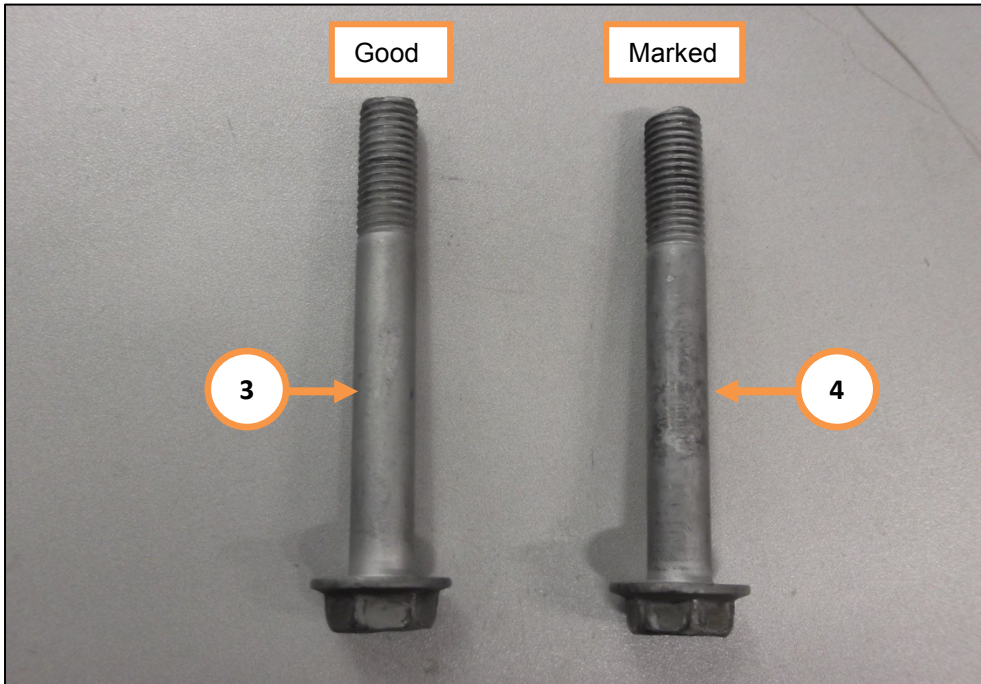
5. Remove both bolts and check for witness marks on the bolt shank. The picture below shows a good bolt shank (3) and one with rubbing marks (4). Supply a picture showing both removed bolts.

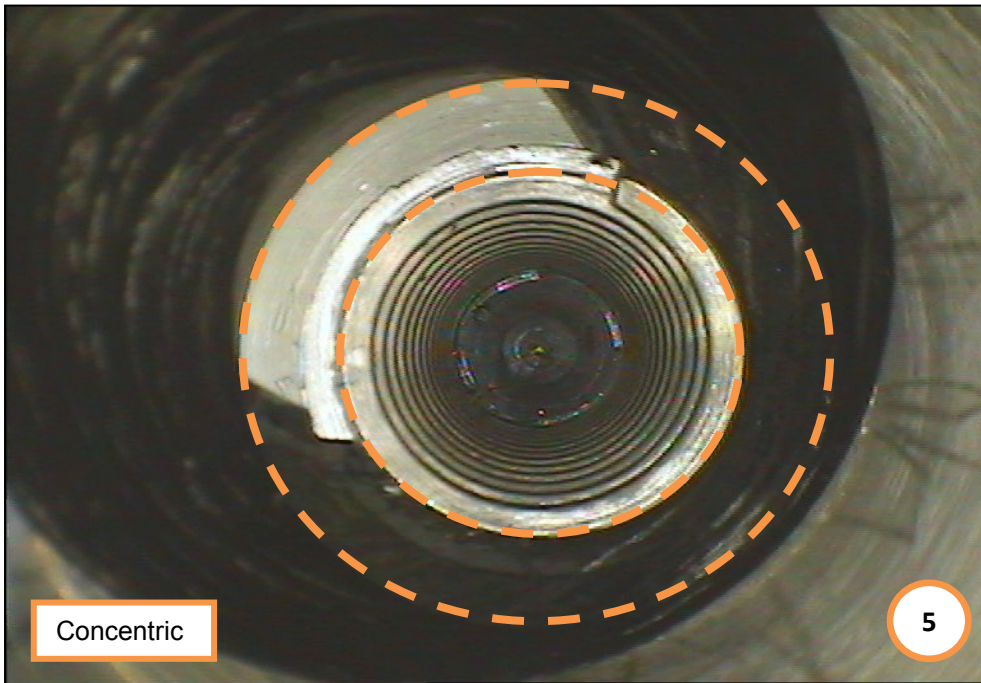
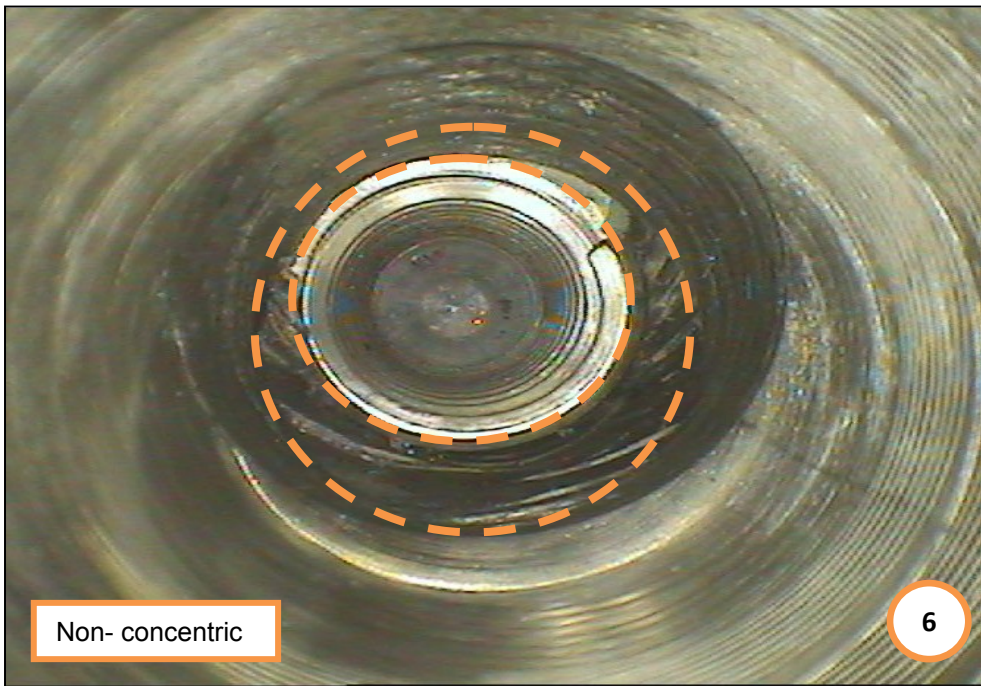
6. Using a borescope, take a picture to show the concentricity of the bolt hole. Below you can see picture of a concentric (5) and non-concentric bolt hole (6).

8. McLaren Technical Support will then advise if the bolt rework procedure can be carried out. If the pictures supplied show that the bolt hole is non-concentric, McLaren will send a Mobile Specialist to carry out a different repair procedure to the vehicle.
