SERVICE CAMPAIGN BULLETIN

CAMPAIGN REF: 023
TITLE : Line Pressure Sensor Incorrect Wake Time
DOCUMENT # : 11 G 005
AFFECTED VEHICLES : 12C Coupe and Spider

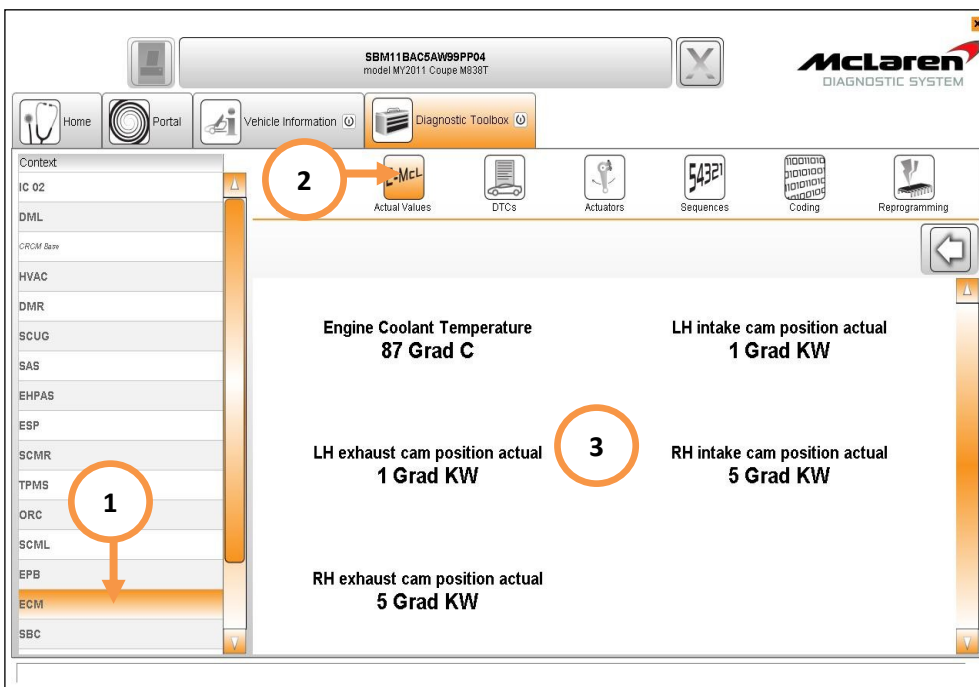
27. The inlet and exhaust camshaft values should be between 1 and 4, both values will fluctuate slightly. If all values are correct then no further action is required so proceed to step 29. If any values are incorrect proceed to step 28 to carry out the camshaft adaption.

26. Select ECM (1), then Actual Values (2) and the following values as per the screenshot below (3). Then select the play button to access the required data screen.

28. Switch the engine off, wait 30 seconds, restart the engine and recheck the values. Repeat this procedure until the target values are achieved.
