# SERVICE CAMPAIGN BULLETIN

**CAMPAIGN REF:** 01P

**TITLE :** Vehicle software update to platform 10.2

**DOCUMENT # :** 11 M 041

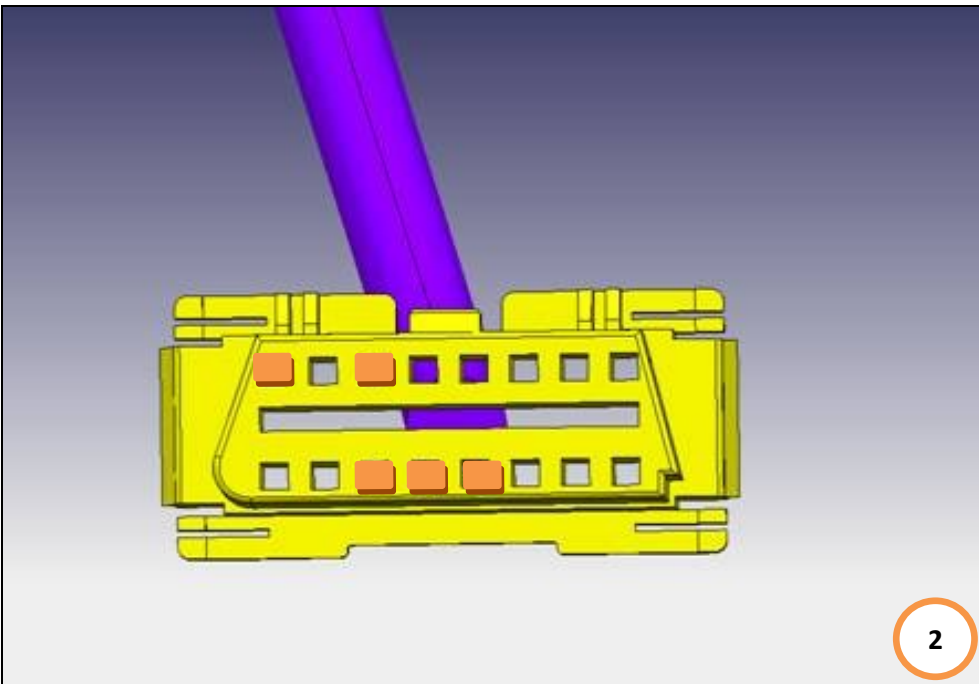
3. Check OBD connector pins 4, 5, 6, 14 and 16, as highlighted below are secure. Loose pins can cause module software download errors. If any of the pins are found to be loose these should be closed up before module reprogramming is carried out (2).

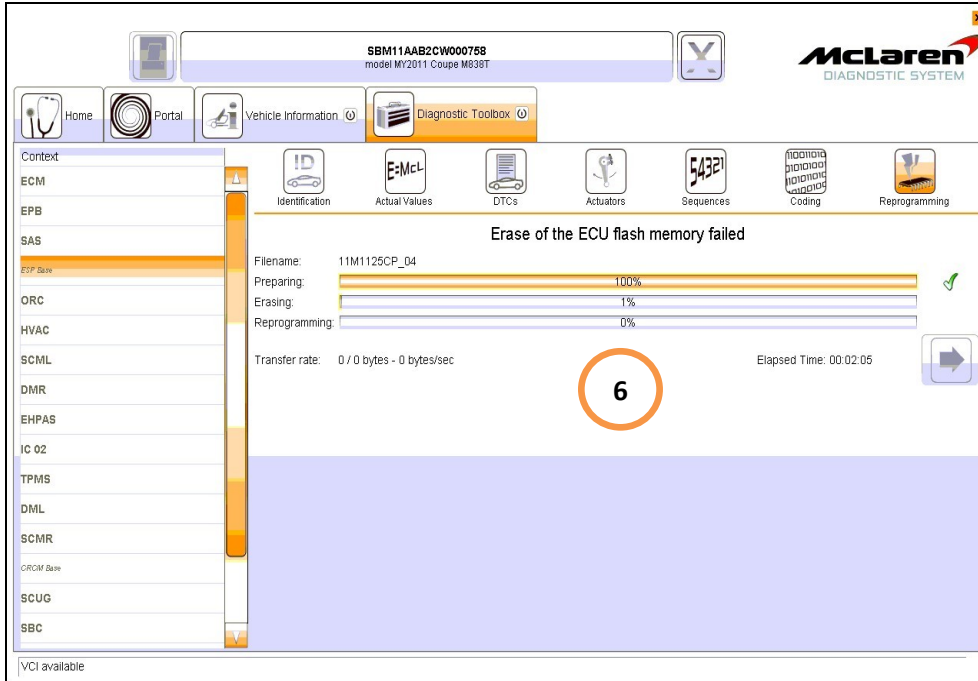
58. After the preparation phase of the download the system may inform the operator that the “Erase of ECU Flash Memory Failed”. In this circumstance the ESP control unit will require a power cycle (6).

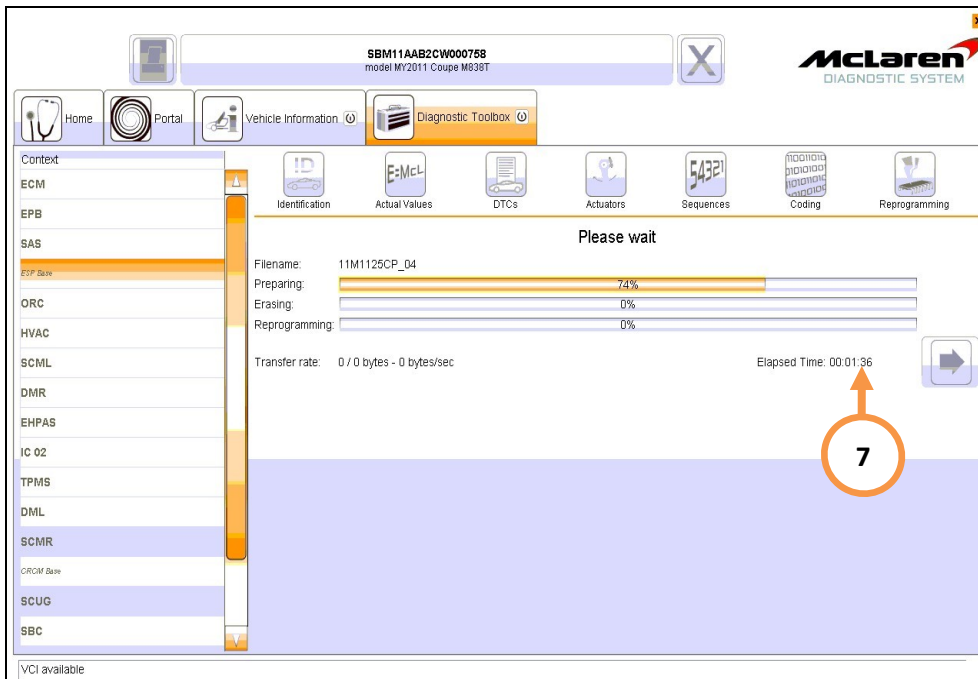
59. Proceed and reflash the ESP module, when the Elapsed Time is between 1.20 to 1.28 seconds (7), disconnect the ESP connector (9) and wait for 5 seconds before reconnecting. The “Preconditions failed” will now be displayed. Proceed to step 61.

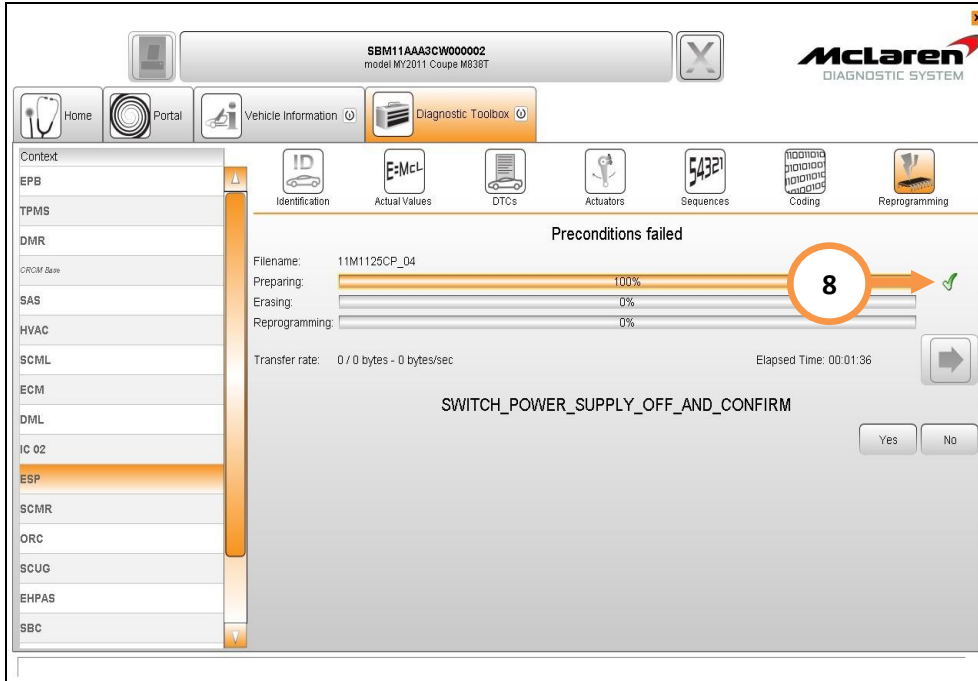
60. After the preparation phase of the download the system may inform the operator that the “Preconditions failed”. In this circumstance the ESP control unit will require a power cycle (8).

61. Disconnect the ESP connector (9) and wait for 5 seconds before reconnecting.
