## SERVICE CAMPAIGN BULLETIN

**CAMPAIGN REF:** 028  
**TITLE :** Module Software Platform Update to 12  
**DOCUMENT # :** 11 M 064  
**AFFECTED VEHICLES :** 12C Coupe and Spider

**SITUATION :** Quality Engineering at McLaren Automotive have released a new software platform for the 12C

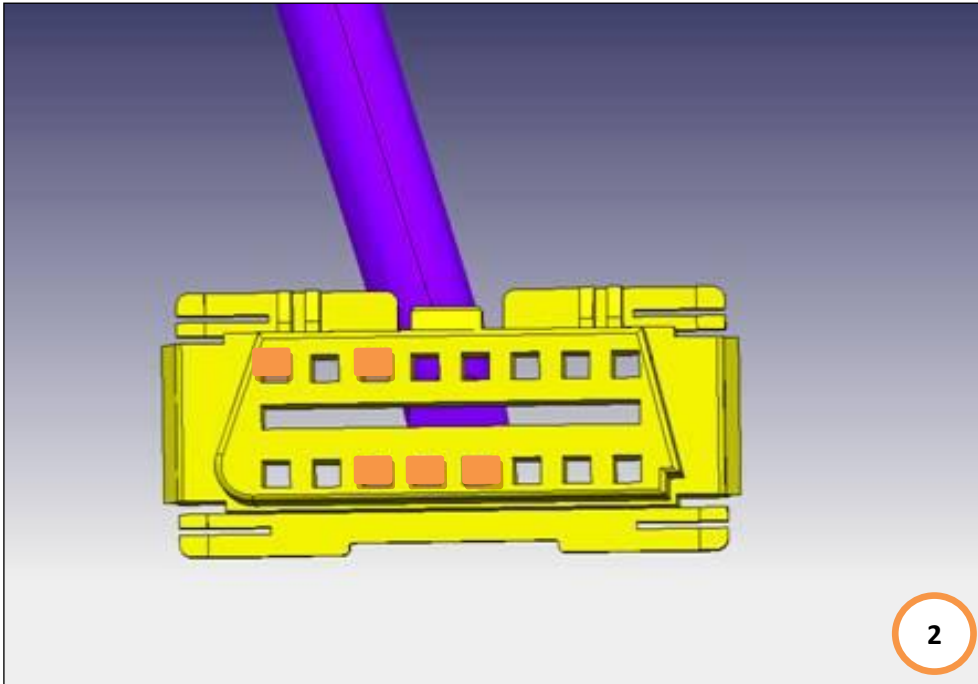
3. Check OBD connector pins 4, 5, 6, 14 and 16, as highlighted below are secure. Loose pins can cause module software download errors. If any of the pins are found to be loose these should be closed up before module reprogramming is carried out (2).
