**NUMBER:** 02-002-13

**GROUP:** Front Suspension

Cold Weather Noise From Front End Over Bumps

**Fiat 500**

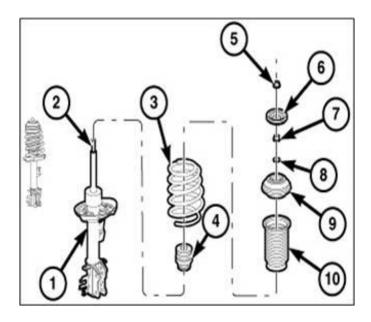
Fig. 1 Strut Disassembly

The customer may experience a noise from the front of the vehicle while going over bumps which may be more noticeable in colder temperatures.

- Remove and disassemble the left and right front strut assemblies. Refer to the detailed removal procedures available in DealerConnect>TechCONNECT> under: Service Info> 02 - Front Suspension> Front> STRUT, Suspension, Assembly> Removal/Disassembly.
- 2. Replace both left and right front jounce bumpers (4) (Fig. 1).

- 1 Strut Damper Assembly
- 2 Strut Damper Shaft
- 3 Coil Spring
- 4 Jounce Bumper
- 5-10 Upper Mount/Retainer and Dust Boot Assembly
- Reassemble and install the left and right front strut assemblies. Refer to the detailed removal procedures available in DealerConnect>TechCONNECT> under: Service Info> 02 - Front Suspension> Front> STRUT, Suspension, Assembly> Assembly/Installation.
