**NUMBER:** 08-023-13

RHW And RHP Navigation System Does Not Show The Proper Vehicle Location

| 2012 | (RT) | Voyager/Grand Voyager/Town and Country<br>(international only) |

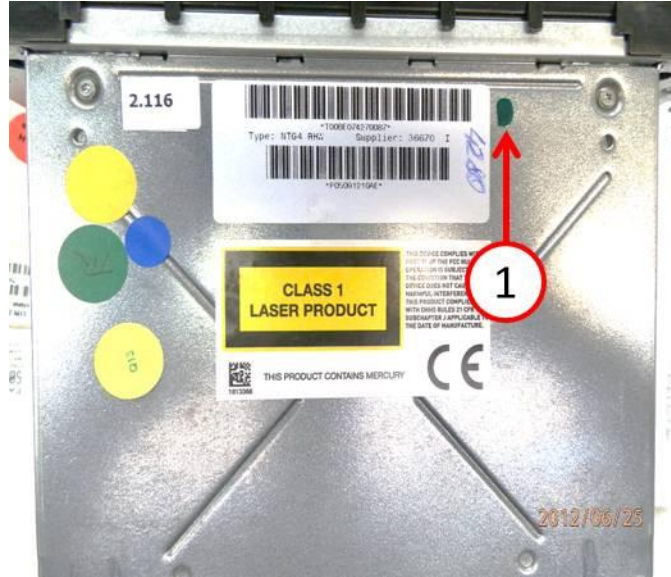
**Fig. 1 Updated radios will have a painted green mark**

1 - Location of green mark.

- 
13. Does the radio have a green dot?
    - a. Yes >>> The updated radio has already been installed in this vehicle. Proceed to [Step #14](#).
    - b. No >>> The radio needs to be replaced, have the parts department order one from the exchange center. **Put the radio back into the vehicle and give it back to the customer. Once the dealer receive the radio, set up an appointment with the customer to install the updated part.**
