NUMBER: 23-017-13

GROUP: Body

Rattle And/Or Buzz At The Right Rear Of Vehicle And/Or Fuel Door Will Not Open

2013 (PF) Dart

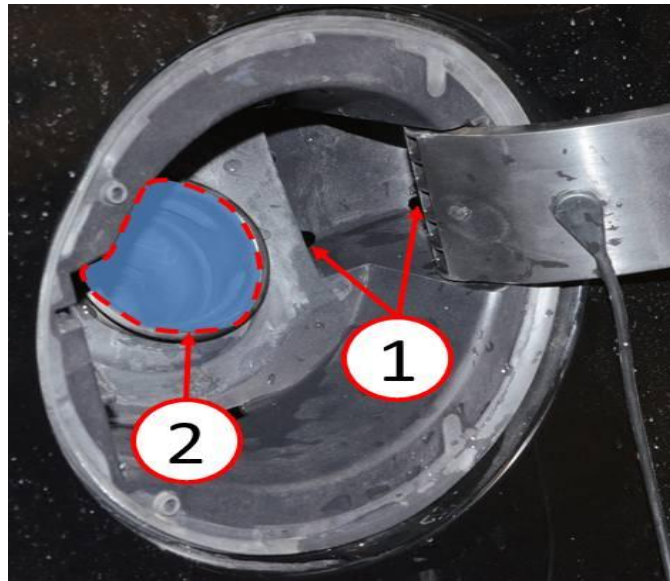
Fig. 1 Fuel Filler Hinge Pocket

- 1 - Hinge Pocket Corner Holes
- 2 - Protect Fuel Filler Neck

NOTE: : The housing and hinge pocket has a thickness of 3mm (1/8in), so a drill stop should be used at 5mm (3/16in) to ensure that nothing behind the housing is damaged from the drill bit.

1. Is this vehicle in the Canadian Market or salt belt states which include Connecticut, Delaware, Illinois, Indiana, Iowa, Maine, Maryland, Massachusetts, Michigan, Minnesota, Missouri, New Hampshire, New York, Ohio, Pennsylvania, Rhode Island, Vermont, West Virginia and Wisconsin?
 - a. Yes >>> Proceed to [Step #2](#).
 - b. No >>> Proceed to [Step #6](#).
2. Open the fuel filler door and remove the fuel cap.
3. Cover the fuel filler neck with a rag or masking tape to prevent debris from entering the area.
4. Drill two 6mm (1/4") holes at the hinge pocket corner locations shown in ([Fig. 1](#)).

WARNING:Do not use an electric drill motor. Use a hand or pneumatic drill.

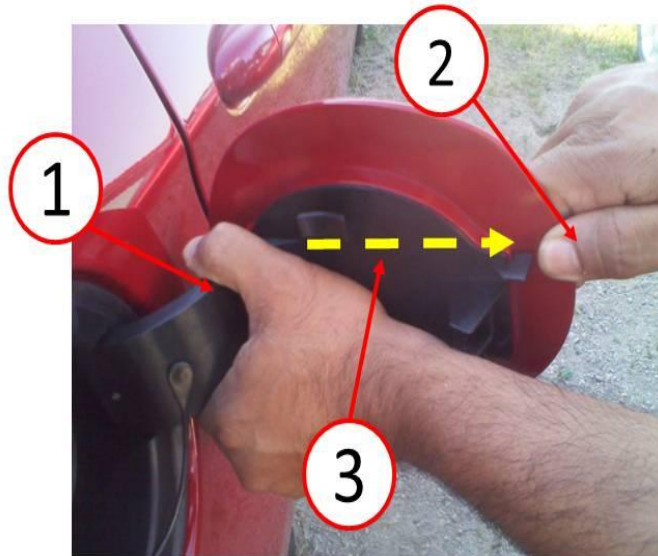
Fig. 2 Fuel Filler Door Inspection

- 1 - Door Hinge
- 2 - Grasp the Fuel Door Here
- 3 - Pull Direction

-
8. Did the fuel door cover separate from the fuel door housing?
 - a. Yes >>> Proceed to [Step #9](#).
 - b. No >>> Return the vehicle to the customer or dealer inventory.

7. Inspect the fuel fill door and verify it is fully seated. With the fuel door open perform a light push pull around the fuel fill door. Grasp the fuel fill door hinge (1) with one hand and position the other at the rear edge of the door (2) lightly pulling out board (3) at the locations shown in (Fig. 2).

9. Remove and reinstall the fuel fill door. Refer to the detailed service procedures available in: DealerConnect> TechCONNECT under: Service Info> 23-Body> Exterior> DOOR, Fuel Fill> Removal/Installation. Did the fuel fill door fully seat when reinstalled?

- a. Yes >>> Return the vehicle to the customer or dealer inventory.
 - b. No >>> Remove the fuel fill door. Refer to the detailed service procedures available in: DealerConnect> TechCONNECT under: Service Info> 23-Body> Exterior> DOOR, Fuel Fill> Removal and proceed to [Step #10](#).

10. Remove and replace the fuel fill housing. Refer to the detailed service procedures available in: DealerConnect> TechCONNECT under: Service Info> 23-Body> Exterior> Housing, Fuel Fill> Removal/Installation.
