NUMBER: 23-018-13

DATE: May 09, 2013

Windshield Wiper Vibration

2013 (JK) Wrangler

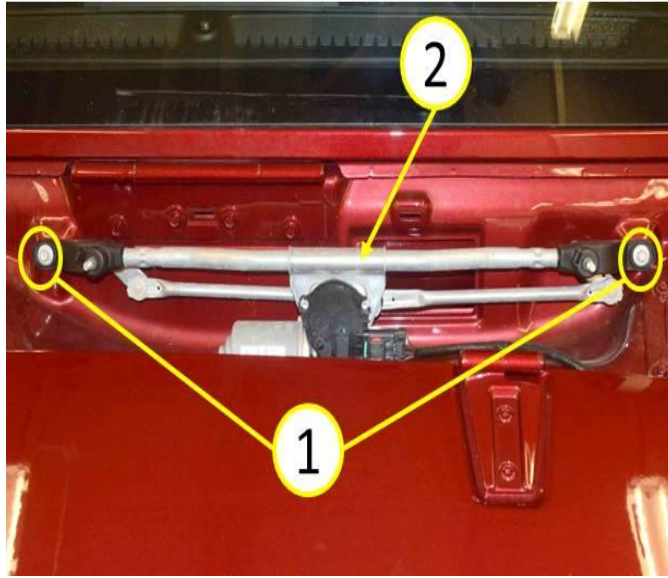
Fig. 1 Front Wiper Module

Windshield wiper blade vibration.

1 - Wiper Module Linkage Bolts

1. Remove and replace the wiper module linkage bolts (Fig. 1) with p/n 06104370AA. Refer to the detailed service information in DealerCONNECT> TechCONNECT> Service Information tab> 08-Electrical> 8R - Wiper/Washers> LINKAGE, Wiper Arm> Removal/Installation.
