NUMBER: 23-017-13 REV. A

Rattle And/Or Buzz At The Right Rear Of Vehicle And/Or Fuel Door Difficult To Open

2013 (PF) Dart

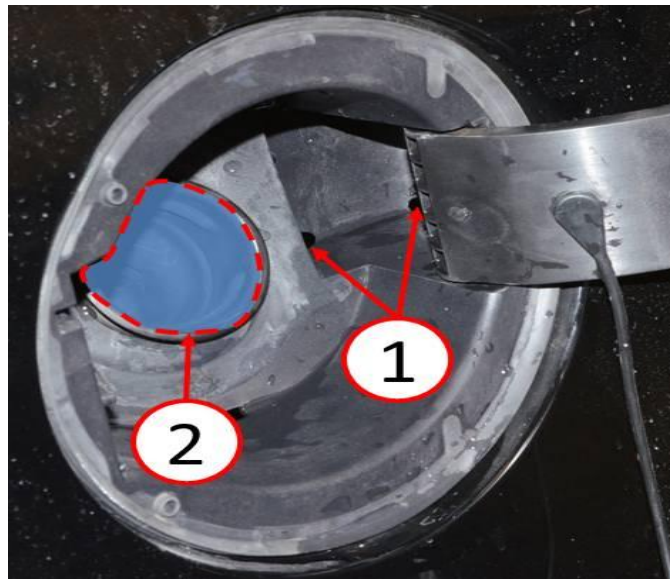
Fig. 1 Fuel Filler Hinge Pocket

1 - Hinge Pocket Corner Holes

2 - Protect Fuel Filler Neck

1. Is this vehicle in the Canadian Markets or in cold states which include Alaska, Colorado, Idaho, Maine, Michigan, Minnesota, Montana, New Hampshire, New York, North Dakota, South Dakota, Utah, Vermont, Wisconsin and Wyoming?
 - a. Yes >>> Proceed to [Step #2](#).
 - b. No >>> Proceed to [Step #6](#).
2. Open the fuel filler door and remove the fuel cap.
3. Cover the fuel filler neck with a rag or masking tape to prevent debris from entering the area.
4. Drill two 6mm (1/4") holes at the hinge pocket corner locations shown in ([Fig. 1](#)).

NOTE: : The housing and hinge pocket has a thickness of 3mm (1/8in), so a drill stop should be used at 5mm (3/16in) to ensure that nothing behind the housing is damaged from the drill bit.

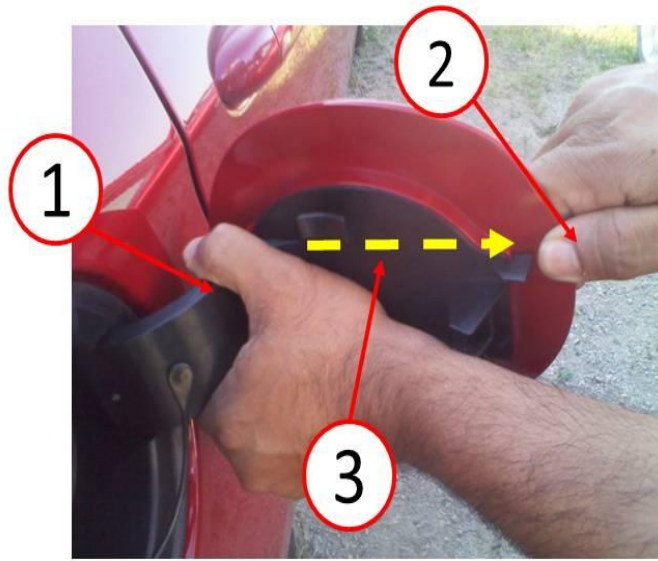
Fig. 2 Fuel Filler Door Inspection

- 1 - Door Hinge
- 2 - Grasp the Fuel Door Here
- 3 - Pull Direction

6. Does this vehicle exhibit a rattle and/or buzz at the right rear of vehicle and/or is built on or after May 03, 2012 (MDH0503XX) and on or before October 08, 2012 (MDH1008XX)?
 - a. Yes >>> Proceed to [Step #7](#).
 - b. No >>> Proceed to [Step #12](#).
7. Inspect the fuel fill door and verify it is fully seated. With the fuel door open perform a light push pull around the fuel fill door. Grasp the fuel fill door hinge (1) with one hand and position the other at the rear edge of the door (2) lightly pulling out board (3) at the locations shown in ([Fig. 2](#)).

-
8. Did the fuel door cover separate from the fuel door housing?
 - a. Yes >>> Proceed to [Step #9](#).
 - b. No >>> Proceed to [Step #12](#).
 9. Remove and reinstall the fuel fill door. Refer to the detailed service procedures available in: DealerConnect> TechCONNECT under: Service Info> 23-Body> Exterior> DOOR, Fuel Fill> Removal/Installation. Did the fuel fill door fully seat when reinstalled?

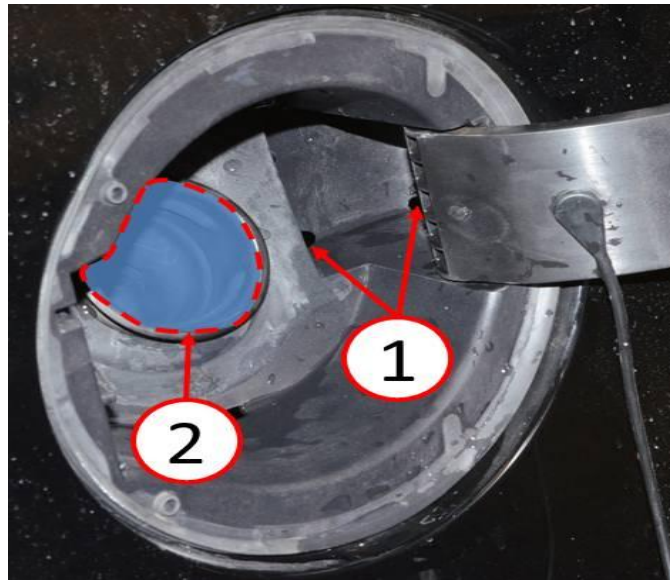
Fig. 3 Fuel Filler Hinge Pocket

- 1 - Hinge Pocket Corner Holes
- 2 - Protect Fuel Filler Neck

12. Is the vehicle located in a market other than Canada or cold states which include Alaska, Colorado, Idaho, Maine, Michigan, Minnesota, Montana, New Hampshire, New York, North Dakota, South Dakota, Utah, Vermont, Wisconsin and Wyoming?
 - a. Yes>>> Proceed to [Step #13](#).
 - b. No>>> Return the vehicle to the customer or dealer inventory.
13. Open the fuel filler door and remove the fuel cap.
14. Cover the fuel filler neck with a rag or masking tape to prevent debris from entering the area.
15. Drill two 6mm (1/4") holes at the hinge pocket corner locations shown in ([Fig. 3](#)).

NOTE: The housing and hinge pocket has a thickness of 3mm (1/8in), so a drill stop should be used at 5mm (3/16in) to ensure that nothing behind the housing is damaged from the drill bit.
