NUMBER: 19-001-13

GROUP: Steering

Rattle From Driver Side Of Instrument Panel Or Steering Wheel Over Rough Roads Or When Turning

2014 (WK) Grand Cherokee (Includes SRT8)

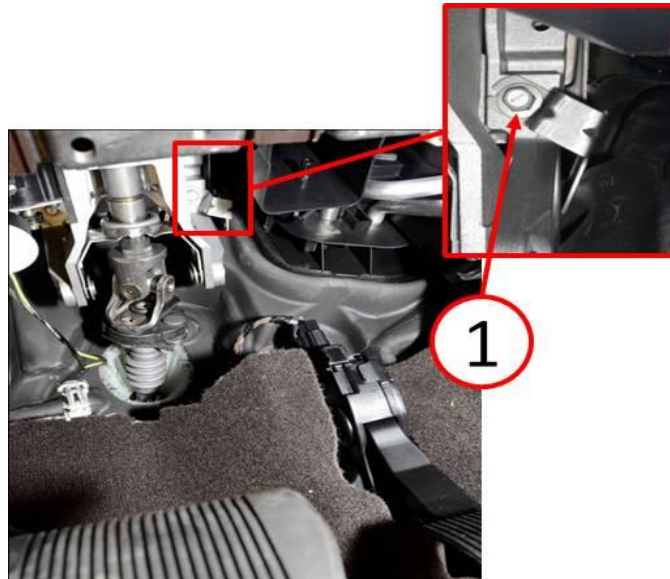
Fig. 3 Steering Column Bracket Removal

Rattle from driver side of instrument panel or steering wheel over rough roads or when turning.

4. Remove the fastener (1) securing the steering column lock control module wiring harness bracket to the steering column and discard the steering column lock control module wiring harness bracket(Fig. 3).

5. Reinstall the fastener that secured the steering column lock control module wiring harness bracket to the steering column and torque to 27 N-m (20 ft-lbs).
6. Connect the courtesy lamp electrical harness (1) to the driver side instrument panel closeout (2) (Fig. 2).
7. Install the driver side instrument panel closeout (2) to the vehicle (Fig. 2).
