NUMBER: 23-002-13

Rattle And/Or Clunking Sound From Convertible Top

2011-2012 (JS) Chrysler 200

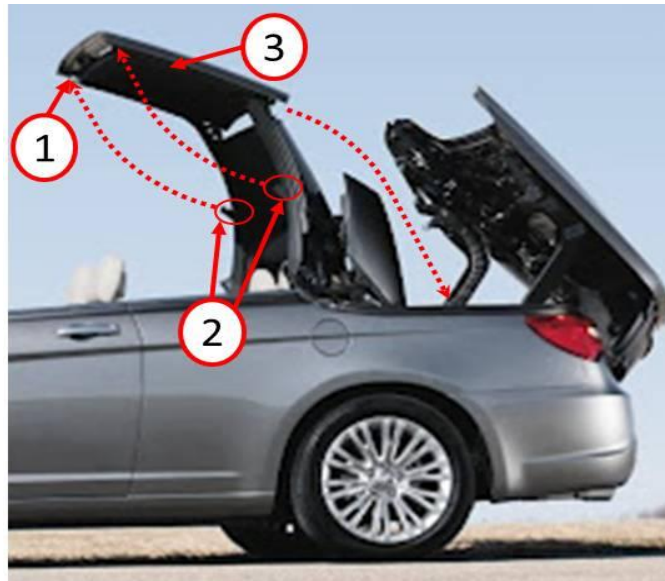
Fig. 1 Hard Top Down Capture System

The hard top assembly is equipped with a down capture mechanism which locks it into the stowed position when lowered. If the hook assembly (2) does not fully engage the down capture mechanism (1) the roof assembly may produce a rattle or clunk due to insufficient retention of the hard top at the hook assembly (Fig. 1). If the customer describes the symptom, perform the Repair Procedure.

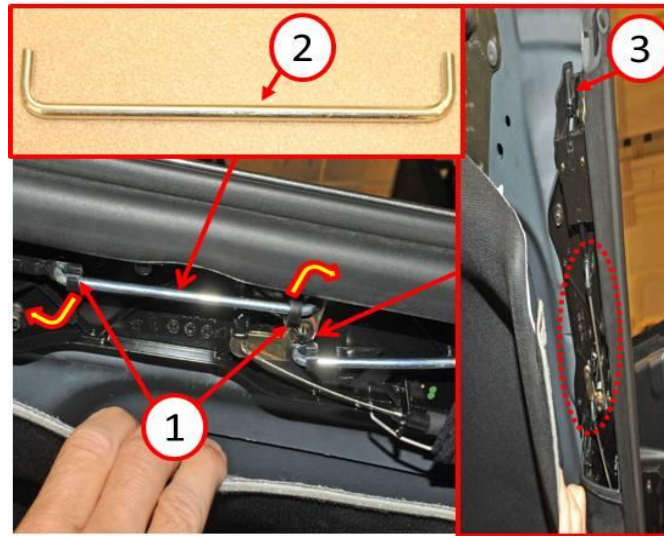
Fig. 2 Down Capture Receiver Rod Replacement

1. Pull the headliner back at the side weatherstrip seal on each side of the forward most hard top roof panel and inspect the forward most down capture receiver rod on each of the down capture latch assemblies.
2. Were either of the right and/or left side receiver rods bent and/or damaged?

- a. Yes >>> Proceed to [Step #3](#).
 - b. No >>> Proceed to [Step #4](#).
3. Replace the damaged or bent receiver rod(s) by swinging the retaining clips open and pulling the rod out of the clips ([Fig. 2](#)).
