**NUMBER:** 16-001-13

**GROUP:** Prop Shaft / U-joint

Driveline Vibration

2012                      DP                                      Ram 4500/5500 Cab Chassis

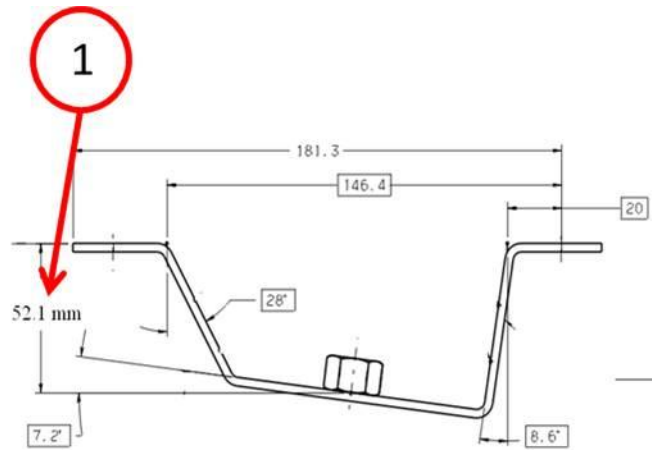
**Fig. 1 Drive Shaft Center Support Bearing Bracket**

A small number of vehicles were built with an incorrect drive shaft center support bearing bracket. The bracket on these vehicles may have an incorrect height which could allow the drive shaft to operate at an angle that could cause the driveline to vibrate while the vehicle is in motion.

2. Measure the height of the drive shaft center support bearing bracket from the attaching fastener to the frame rail (Fig. 1). The distance should be 52.1 mm (2 inches). Incorrect drive shaft center support bearing brackets will be 82 mm (3.25 inches).

8. Install new drive shaft center support bearing bracket (p/n 52123065AB) securing it with the attaching fasteners. Tighten the bolts to 54 N·m (40 ft. lbs.).

9. Align center bearing with reference marks on center bearing bracket and tighten bolts to 54 N·m (40 ft. lbs.).
10. Lower the vehicle.
