**NUMBER:** 23-003-13

Left And/Or Right Rear Interior Speaker Bolster Is Raised At Quarter Panel Trim

2013 (RT) Caravan / Town and Country

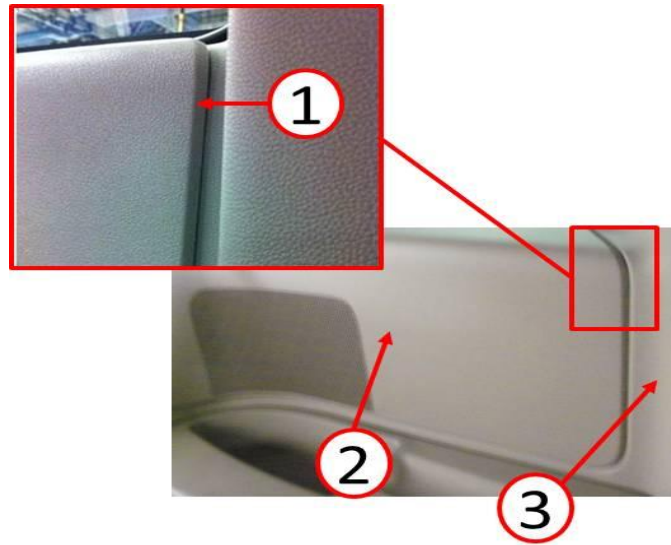
**Fig. 1 Speaker Bolster Trim**

1. Inspect the right and left rear speaker bolster at the area shown in ([Fig. 1](#)). Was the speaker bolster over flush and seated on the A-surface of the quarter panel trim?

- 1 - Over flush and seated on the a-surface of the interior quarter panel trim
- 2 - Interior speaker bolster
- 3 - Interior quarter panel trim

- a. Yes>>> Remove and replace the right and/or left rear speaker bolster. Refer to the detailed service procedures available in: DealerConnect> TechCONNECT under: Service Info> 23-Body> Interior> Panel, Quarter Trim, Bolster> Removal/Installation.
- b. No>>> Proceed to [Step #2](#).
