**NUMBER:** 25-001-13

**GROUP:** Emissions Control

MIL Illumination Due to P2000, P2A00 and/or P2A01

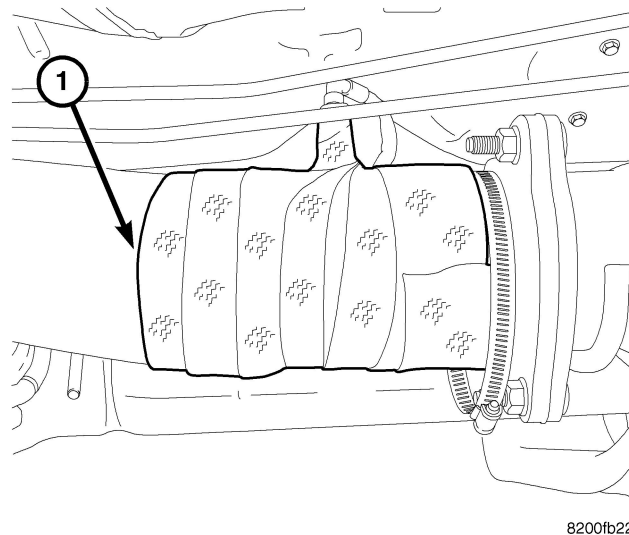
**Fig. 1 PROPER WRAP INSTALLATION**

**NOTE:** If the vehicle is equipped with an O2 sensor wrap, verify proper O2 sensor wrap installation, (Fig. 1). If the O2 sensor wrap has been installed properly and is not damaged or if the vehicle is equipped with an O2 sensor blanket and is not damaged, this bulletin will not address the symptom/condition. Follow the diagnostic information provided in DealerCONNECT>TechCONNECT>Service Info>Group 28 DTC Based Diagnostics>Module, Engine control (ECM), 6.7L>Standard Procedure>PRE-DIAGNOSTIC TROUBLE SHOOTING PROCEDURE, 6.7L or DealerCONNECT>TechCONNECT>Service Info>Group 29 Non-DTC Diagnostics>Drivability - Diesel, 6.7L>Diagnosis and Testing>PRE-DIAGNOSTIC TROUBLE SHOOTING PROCEDURE, 6.7L.

1 - O2 SENSOR WRAP

1. Raise the vehicle on a hoist.
2. If the vehicle is already equipped with a wrap or blanket but this bulletin is being performed because they are damaged, remove the damaged wrap or blanket from the exhaust pipe.
