NUMBER: 23-002-13 REV. A

GROUP: Body

DATE: January 25, 2013

Rattle And/Or Clunking Sound From Convertible Top

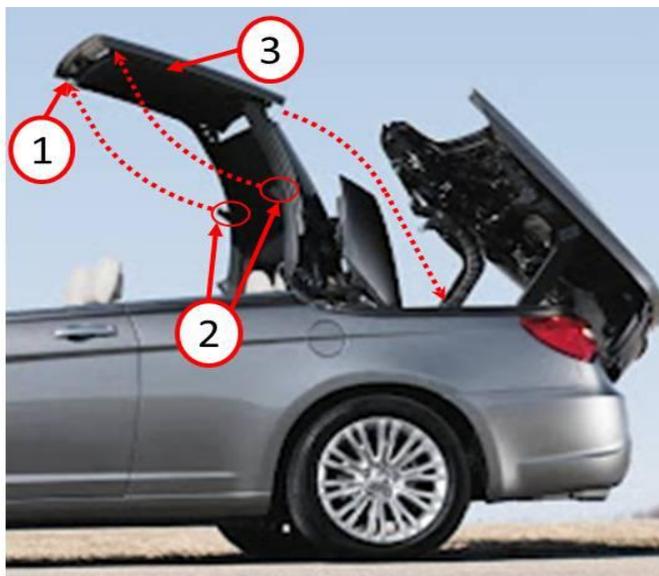
Fig. 1 Hard Top Down Capture System

The hard top assembly is equipped with a down capture mechanism which locks it into the stowed position when lowered. If the hook assembly (2) does not fully engage the down capture mechanism (1) the roof assembly may produce a rattle or clunk due to insufficient retention of the hard top at the hook assembly([Fig. 1](#)). If the customer describes the symptom, perform the Repair Procedure.

- 1 - Front Down Capture Mechanism (Latches to C-Pillar Hook Assembly)
 2 - Down Capture Hook Assembly (Retracts From Upper C-Pillar)
 3 - Down Capture Receiver Rod/Latch Assembly (Located Under Headliner)

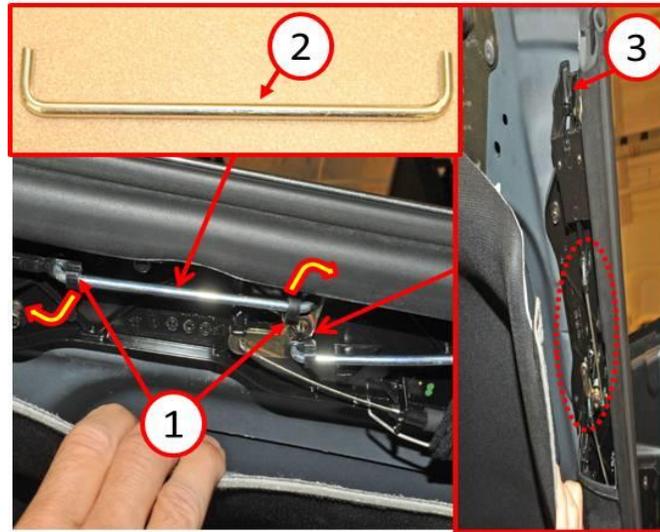
Fig. 2 Down Capture Receiver Rod Replacement

- 1 - Retaining Clips (Secure Receiver Rod)
- 2 - Receiver Rod (Actuates Down Capture Latch)
- 3 - Down Capture Mechanism (Located Under Headliner / Latch Protrudes Out Forward Edge)

- a. Yes >>> Proceed to [Step #3](#).
 - b. No >>> Proceed to [Step #4](#).
3. Replace the damaged or bent receiver rod(s) by swinging the retaining clips open and pulling the rod out of the clips ([Fig. 2](#)).

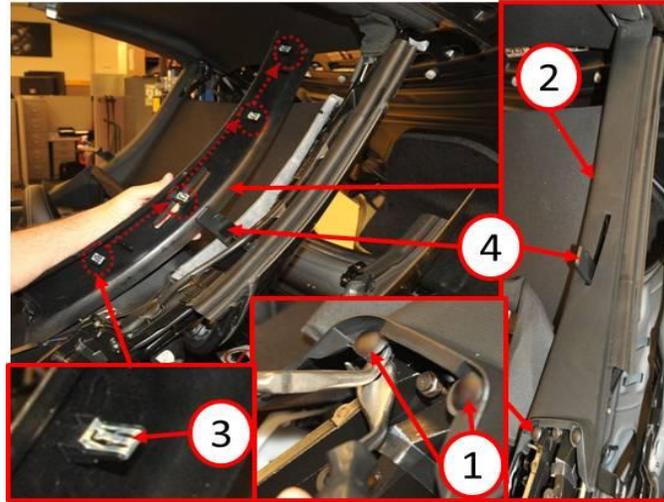
Fig. 3 Upper C-Pillar Trim Removal

- 1 - Plastic Push Clips (2 Retain End of C-Pillar Trim)
- 2 - C-Pillar Trim (Covers Down Capture Hook Assembly)
- 3 - Metal Push Clips (4 Retain C-Pillar Trim)

-
4. Remove the upper C-pillar trim (2) from both the left and right side of the hard top assembly to gain access to the down capture hook assembly (4) ([Fig. 3](#)).

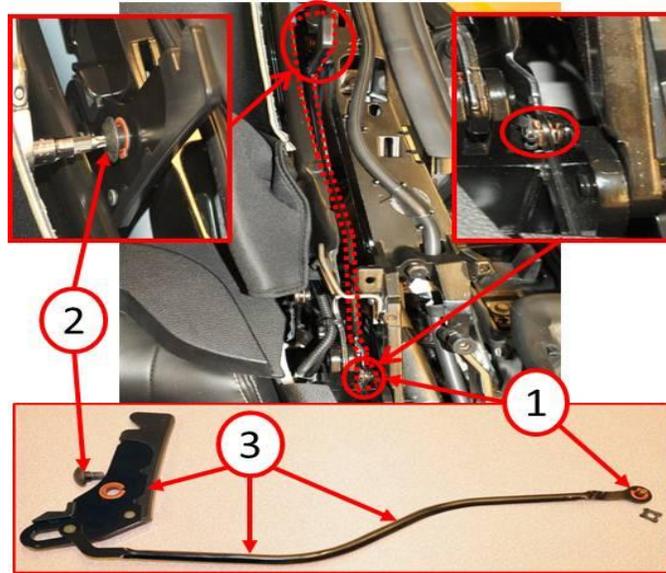
Fig. 4 Side Rail Down Capture Hook Replacement

- 1 - Push Clip Retainer and Pin Clevis
- 2 - Torx Shoulder Bolt
- 3 - Side Rail Down Capture Hook Assembly

-
5. Remove the push clip retainer and pin clevis (1) along with the torx shoulder bolt (2) (Fig. 4) to replace the side rail down capture hook assembly with the appropriate side/color specific revised part indicated in the parts section.
