NUMBER: 14-002-13

GROUP: Fuel System

Fuel Spit Back During Refueling Due To Inlet Check Valve (X48 Lifetime Warranty Extension)

2005 - 2006 (HB)

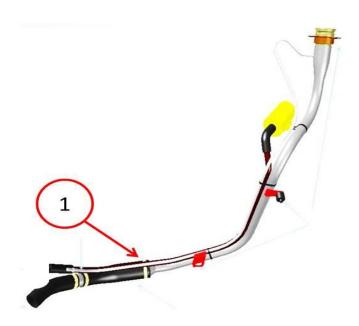
Fig. 1 Fuel Filler Tube

- 2. Remove Left rear wheel.
- 3. Remove the left quarter panel splash shield.
- 4. On new fuel filler tube verify and write down existing torque (Fig. 1).

1 - worn gear hose clamp

NOTE: It may be necessary to loosen the worm gear hose clamp and rotate to allow the fuel filler neck to fit between the body and frame. If clamp is loosened then once installed re-torque to noted value.

- 5. Replace the fuel filler tube, Following the detailed procedures found in DealerCONNECT>TechCONNECT Service Info > 14 Fuel System> Fuel Delivery > Tube, Fuel Filler removal and installation procedures.
- 6. Install the left quarter panel splash shield. There are 4 or 5 plastic retaining rivets.
- 7. Install left rear wheel.
