**NUMBER:** 31-002-13

**GROUP:** Collision Bulletin

Blending Clearcoat During The Refinish Process

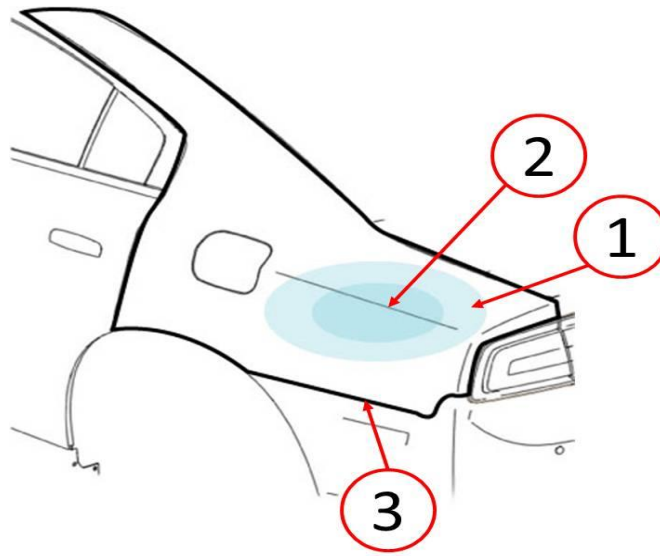
***Fig. 1 Clearcoat Blended Panel***

Partial clearcoat blending is not an approved warranty repair process for Chrysler vehicles. Partial clearcoat blending is a process that generally involves adding solvents to a paint manufacturers clearcoat mixing formula to reduce the viscosity. This will not only degrade the durability of materials but it could also produce additional emissions. Partial clearcoat blending is achieved by adopting processes that are typically used to transition basecoat color on repair areas. Clearcoat should always be applied to the entire surface area of a body panel and mixed to manufacturers specifications. Any vehicle repaired with the partial clearcoat blending process will prematurely fail and eventually result in a clearcoat delamination condition. An example of clearcoat blending is shown in ([Fig. 1](#)).

As shown in (Fig. 1) clearcoat is not applied to the entire quarter panel surface area, but only to a small portion. The repair area will initially appear sufficient but depend on how the process was performed the repair area will begin to degrade in 6 months to 3 years. Clearcoat (1) has been applied to the entire quarter panel in (Fig. 2) and basecoat (2) was applied to cover the repair area, which is the proper repair process.
