**SER-APU13-007**  
**12/13/2013**

## **SUBJECT: PG1000 APU Shore Power Cable**

## PG1000 Shore Power Kit

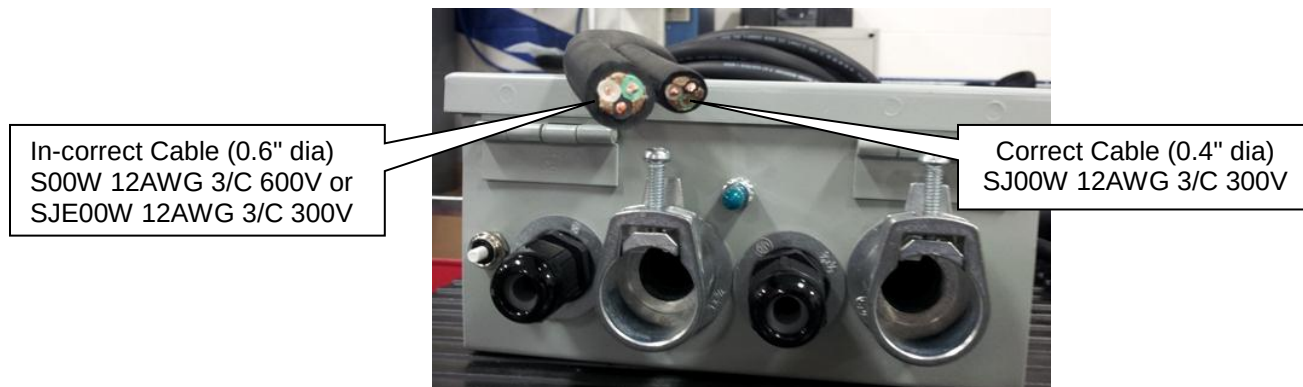
Cable Assembly #**29-035-00K** is part of the **PG1000 Shore Power Kit**. It is the AC cable assembly that runs from the Shore Power Outlet to the Shore Power Manager. Certain PG1000 Shore Power Kits shipped prior to September 6, 2013 may have an oversized cable in the kit. This will cause difficulty when attempting to connect the cable to the Shore Power Manager due to the thickness of the insulation.

The correct cable assembly has a cable diameter of approximately 0.4 inches (1.0 cm.) and is stamped **SJOOW 12AWG 3/C 300V**.

If the non - installed kit contains a cable assembly with a diameter of approximately 0.6 inches (1.5 cm) and stamped **SOOW 12AWG 3/C 600V** or **SJE00W 12AWG 3/C 300V** the cable **MUST** be replaced prior to installing the kit with **Service part # 29-035-00K**

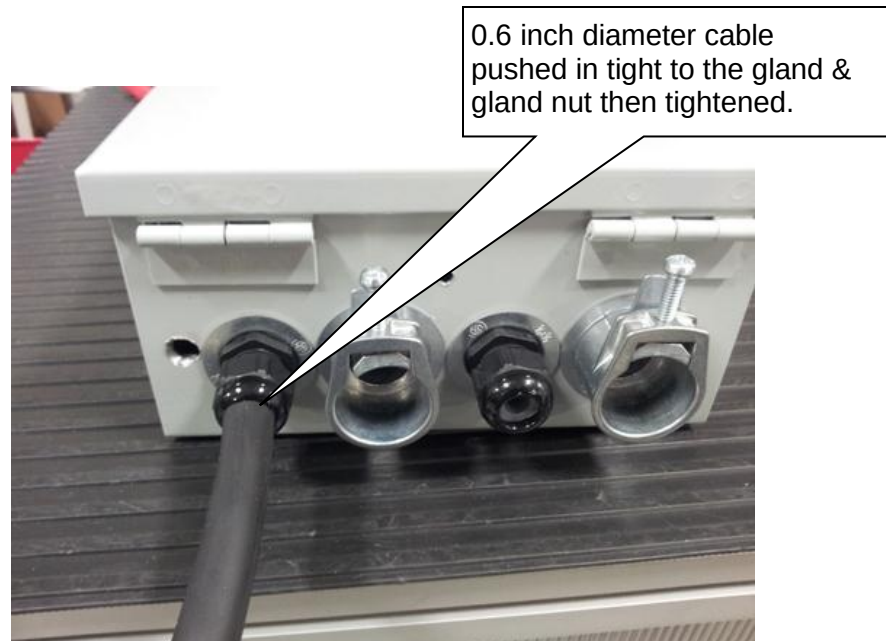
- For cables that do not have the cable's outer jacket butted up against the gland, inspect the insulation on the white, black and green wires to ensure there are no cuts or other damage. If they are damaged, replace the cable with the 0.4 inch diameter cable. If the insulation is not damaged, loosen the gland, push the cable deeper into the gland so that its outer jacket butts up against the gland and then re-tighten the gland and ensure the wires are still routed acceptably inside the box. Then install the suitably sized P-Clip within 9" of the gland and secure to a suitable metal floor or wall panel. Make remarks in the warranty claim.

- Ensure shorepower unit is un-plugged from any power source and that the APU engine is off.
- Ensure the cable's outer jacket only is stripped off, butted up against the gland at the Shore Power Manager and that the gland is tightened down properly as per the photo below. Also, within 9 inches of the gland, install a suitably sized rubber or nylon coated steel P-Clip and fastens to suitable metal floor or wall panel. Make remarks in the warranty claim.
