To All Lamborghini Dealers and Licensed Service Point
From Customer Service Department
Subject Starter Ventilation Enhancement
Group 9.11.00
Date 15th/11/2013
Pages 6

Starter ventilation enhancement.

All Lamborghini Aventador LP 700 Coupe and Roadster MY 12,13 and 14 from VIN CLA0091 to VIN ELA02238.

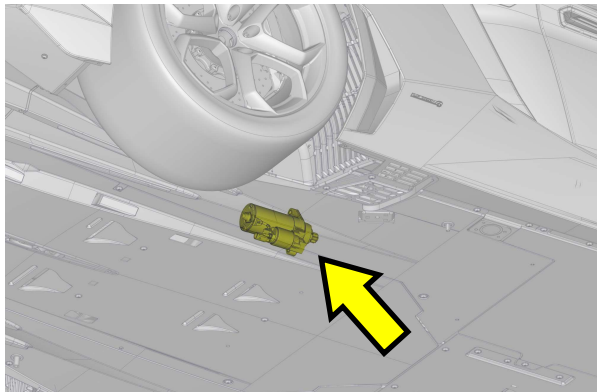
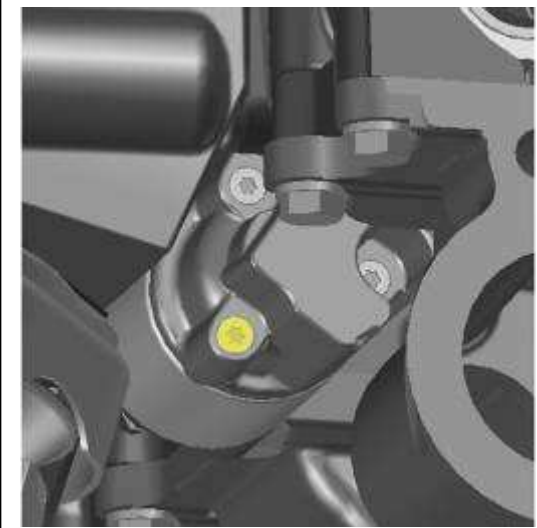
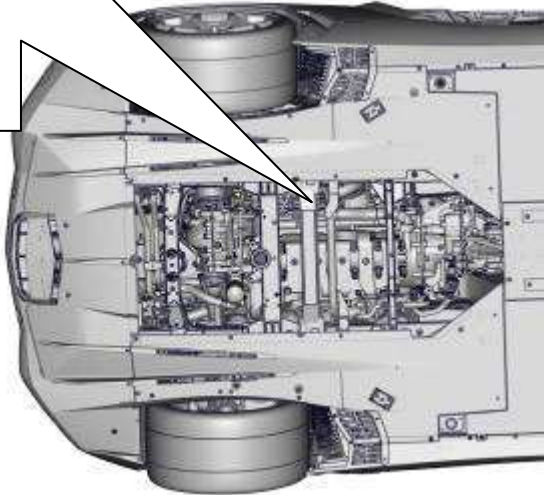
2	Place vehicle on suitable hoist and lift it properly to work safe from risks.
3	Identify the working Area and the lower screw to be replaced

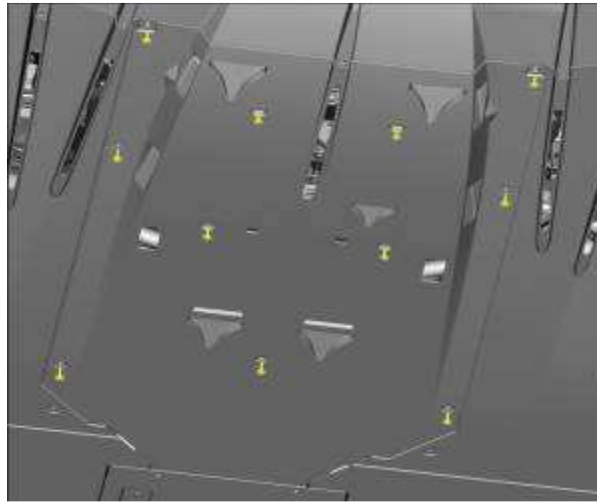
Remove vehicle rear central bottom panel (082503)

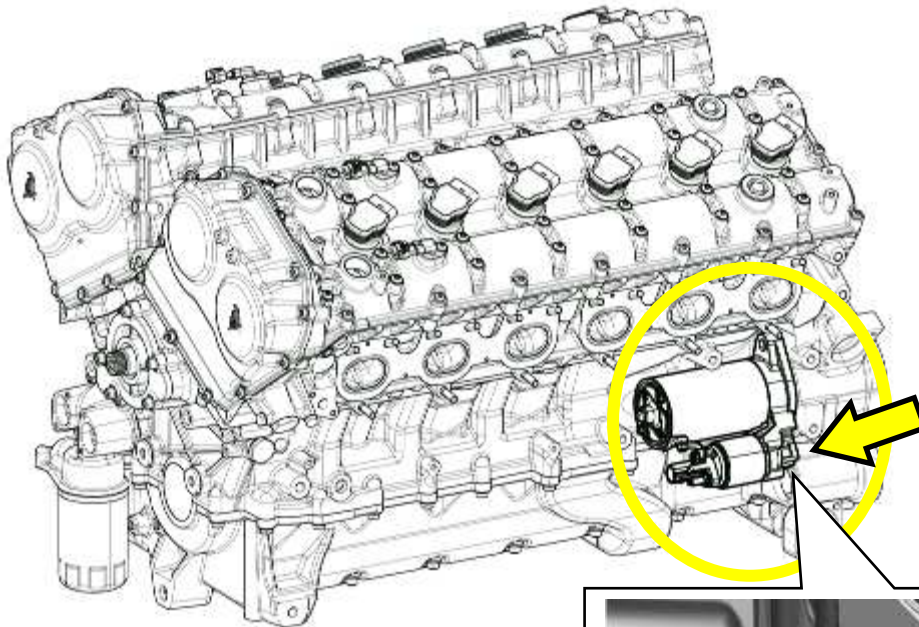
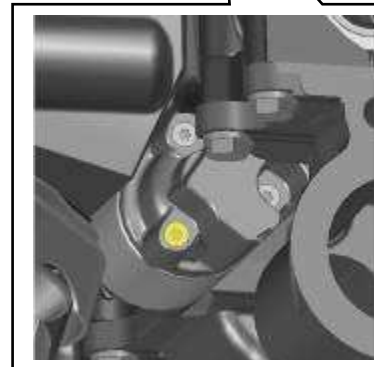
Detect the screw to be replaced: lower screw of starter motor.
