Service Information Bulletin

SUBJECT	DATE
SPN 3216/FMI 13 - EPA10/GHG14	October 2013

Publication Number / Title	Platform	Section Title	Change
DDC-SVC-MAN-0084	EPA10 – GHG14 DD Platform	SPN 3216/FMI 13 - EPA10	Currently, the two troubleshooting procedures for SPN 3216/13, EPA10 and GHG14, reference removal of the Outlet NOx sensor. The reference needs be to the Inlet sensor instead. Markup for both troubleshooting procedures are included in attachment.
		SPN 3216/FMI 13 – GHG14

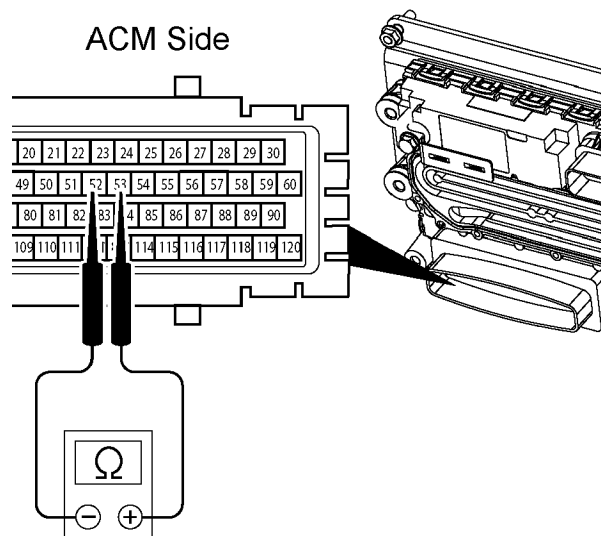
d150153

- b. If the resistance is less than 5 ohms, Go to step 15.
15. Test the ACM2 internal resistor; measure the resistance between pins 52 and 53 on the ACM2 120-pin connector.

- a. If the resistance is between 50 and 70 ohms, replace the SCR Inlet NOx Sensor. Refer to section "Removal of the EPA10 Selective Catalyst Reduction Inlet NOx Sensor"
- b. If the resistance is NOT between 50 and 70 ohms, replace the ACM2.

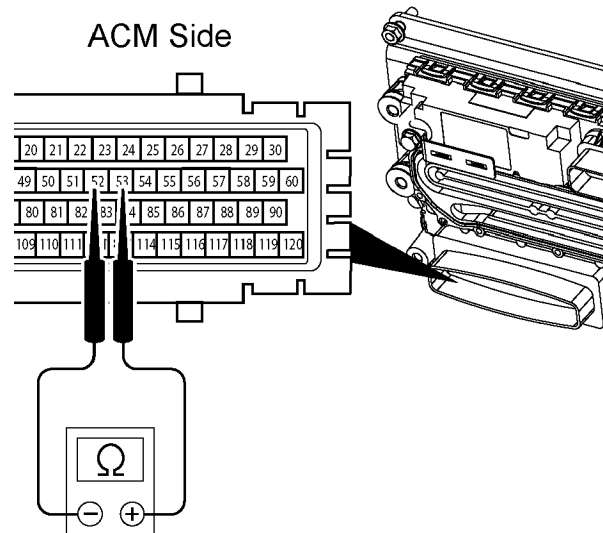
d150153

- b. If the resistance is less than 5 ohms, Go to step 15.
15. Test the ACM2.1 internal resistor; measure the resistance between pins 52 and 53 on the ACM2.1.

- a. If the resistance is between 50 and 70 ohms, replace the SCR inlet NOx Sensor. Refer to section "Removal of the GHG14 Selective Catalytic Reduction Inlet NOx Sensor"
- b. If the resistance is NOT between 50 and 70 ohms, replace the ACM2.1.
