BT12-018a

January 16, 2013

## 2013 JX35; SQUEAKS AND RATTLES FROM INSTRUMENT PANEL

2013 JX35 (L50)

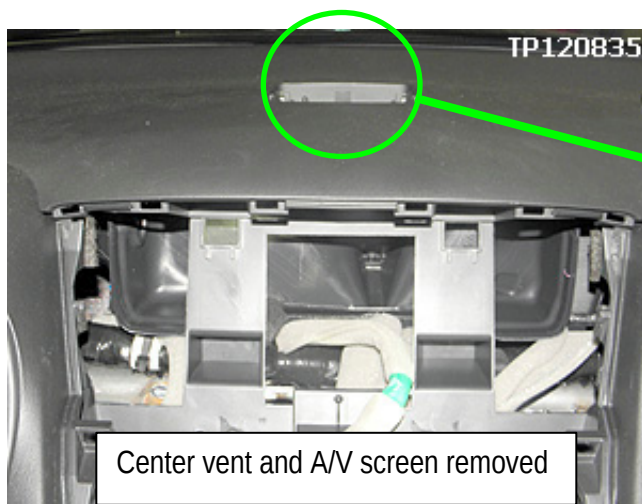
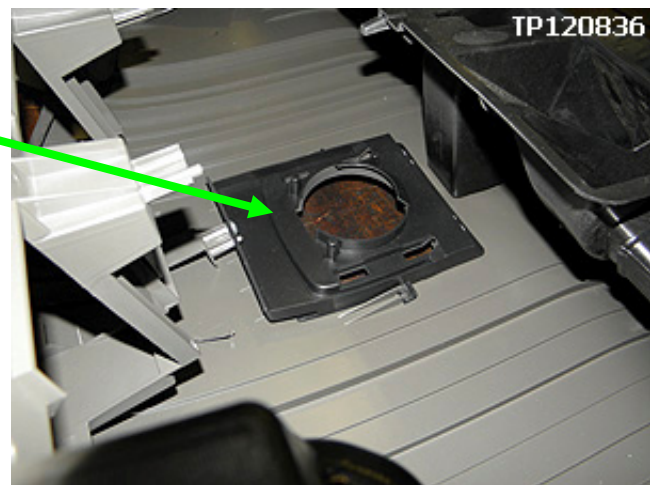
Fasteners on Speaker Bracket may not be fully seated and may make a noise.

- Figures 1 and 2 show locations of center Speaker Bracket screws (Figures 2, 3 and 4 are shown with dash removed and upside down for reference only).

- If a rattle is confirmed in the top center of dash area, check all 3 Speaker Bracket fasteners to ensure screws are fully seated and tighten as necessary, and add Flocking tape to Speaker Grill clips (page 3).

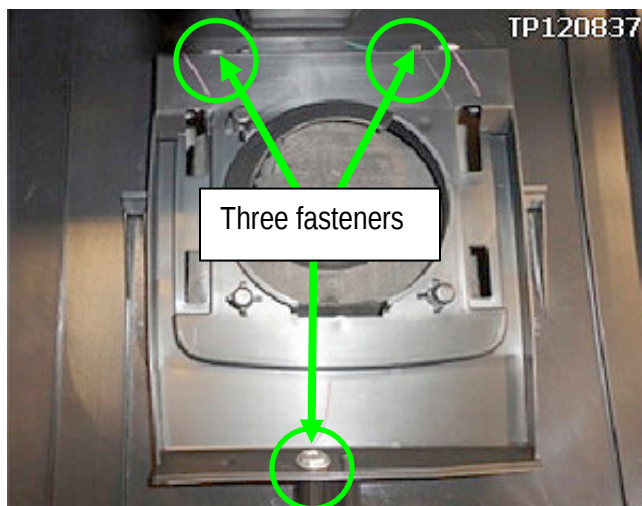
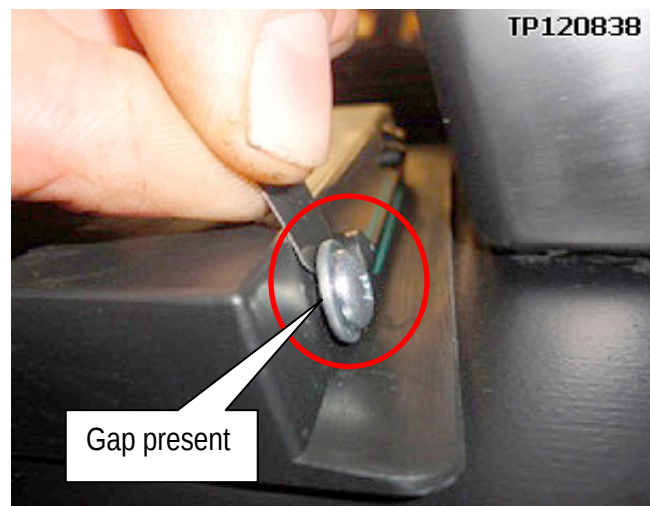
- Figures 3 and 4 show Speaker Bracket screws and possible gap.

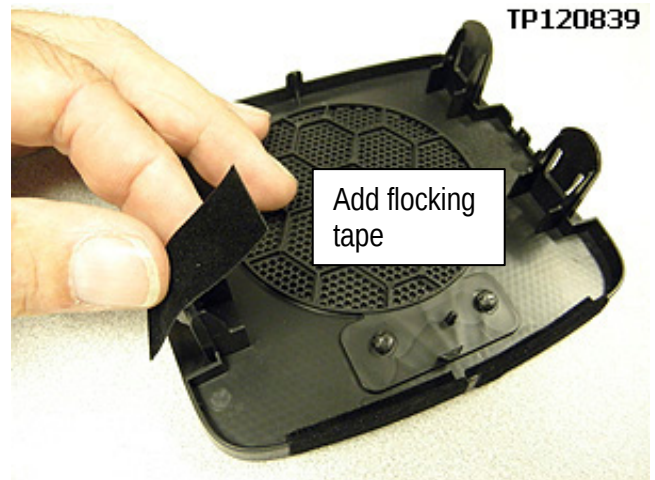
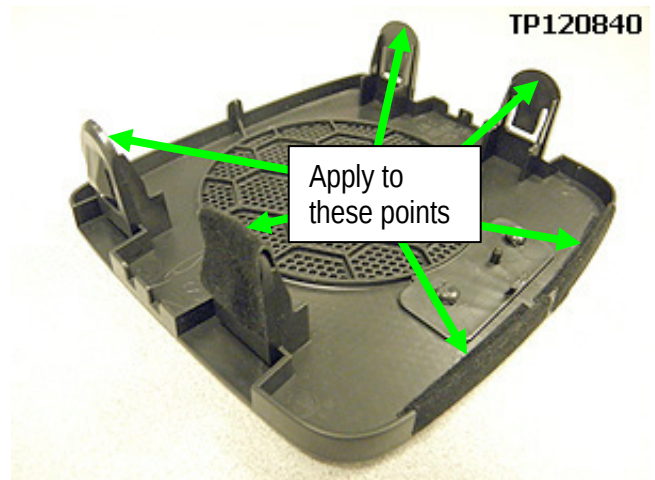
Clips on Speaker Grill may rub against Speaker Bracket and cause a noise.

- With Speaker Grill removed apply 6 pieces of Flocking tape (J-50397-8) cut to 45mm lengths as shown in Figures 5 and 6.

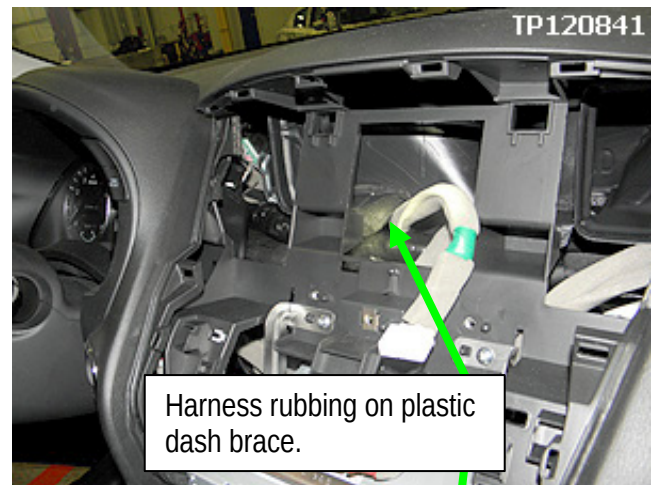
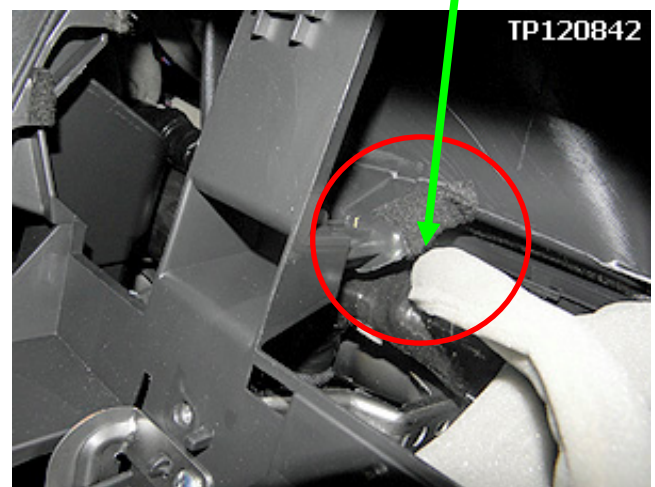
Instrument Panel Main Harness may rub against Center Air Duct bracket and may make a noise.

- If a rattle is present in the center vent area inspect for the Main Harness rubbing against the center air duct support (Figures 7 and 8).

- Apply additional “EPDM SEMI CLOSED CELL” foam (J-50397-2) between Main Harness and Center Air Duct bracket as shown in Figure 7.
- The foam tape must be long enough to completely isolate the Main Harness from the plastic bracket.

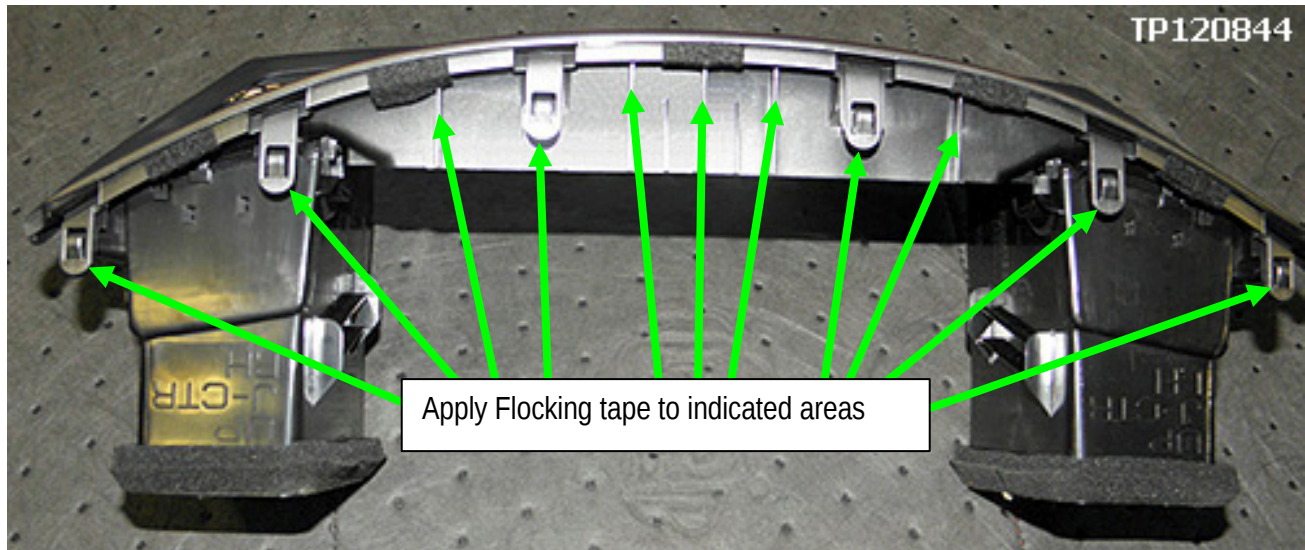
Figure 10

Center Air Vent Lid may rub against Instrument Panel Assembly and may make a noise.

- If a noise is present in the Center Air Vent Lid area, apply Flocking tape (J-50397-8) to indicated areas in Figure 10.

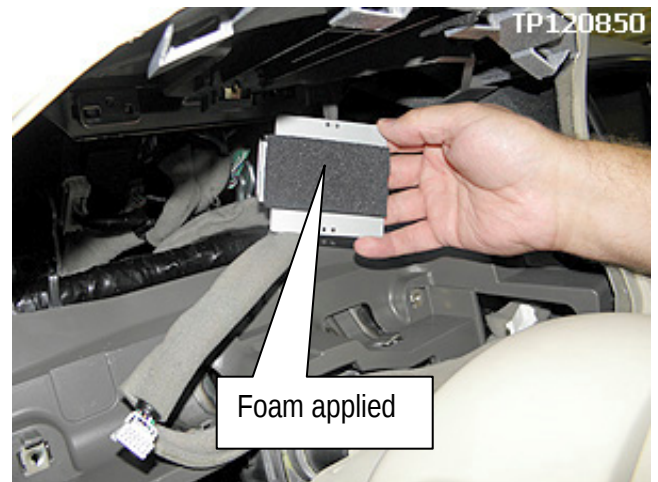
GPS and telephone antenna brackets may contact Body Control Module (BCM) and may make a noise.

3. Apply 90 mm of "EPDM SEMI CLOSED CELL" foam (J-50397-2) to back of telephone antenna.
  - Figure 16 shows antenna with foam applied.

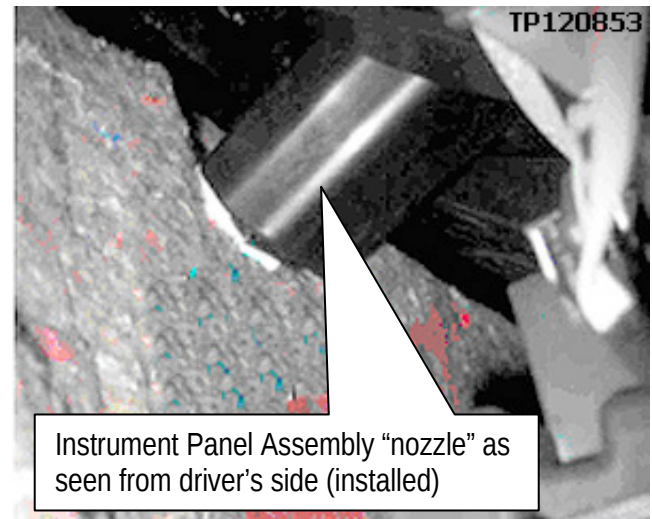
The Instrument Panel Assembly may not be completely aligned with bulkhead mount and could rub, and may make noise.

Figure 19 shows Instrument Panel Assembly “nozzle” installed over bulkhead mount.

2. Pull down firmly on Instrument Panel Assembly “nozzle” with 20 – 40 lbs of downward force to align bulkhead mount and Instrument Panel Assembly.

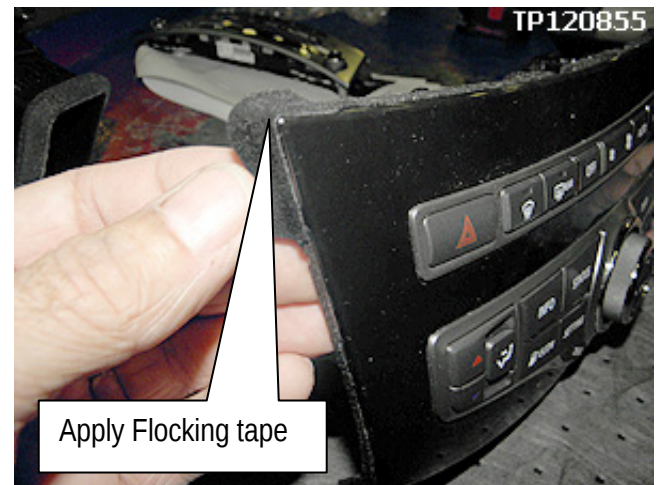
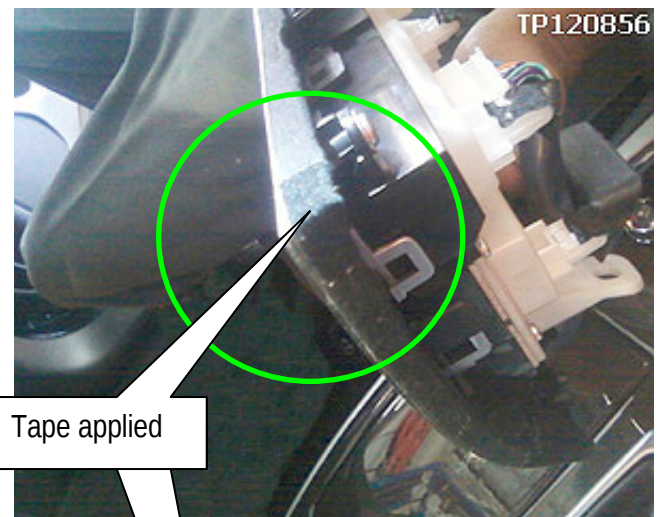
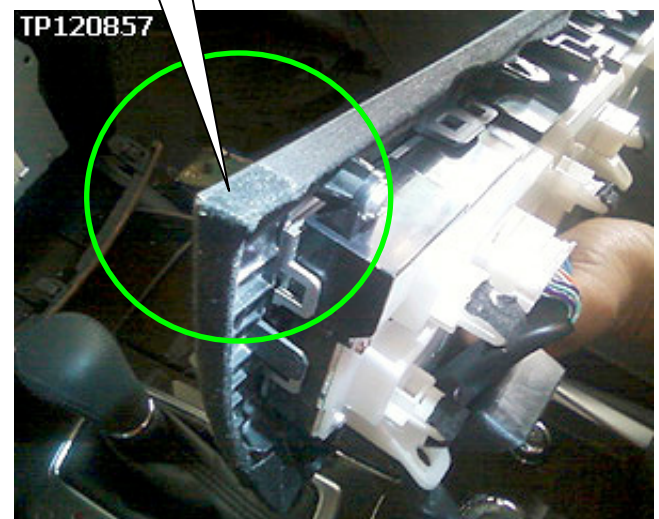
The HVAC panel may make contact with Instrument Panel Assembly, Center Air Vent Lid, or Audio Switch Plate and may make noise.

- Add Flocking tape (J-50397-8) to all 4 corners of HVAC control panel to cover any exposed plastic.
