EL10-042e

January 17, 2013

## NAVIGATION AND AUDIO/VIDEO SOFTWARE UPDATE

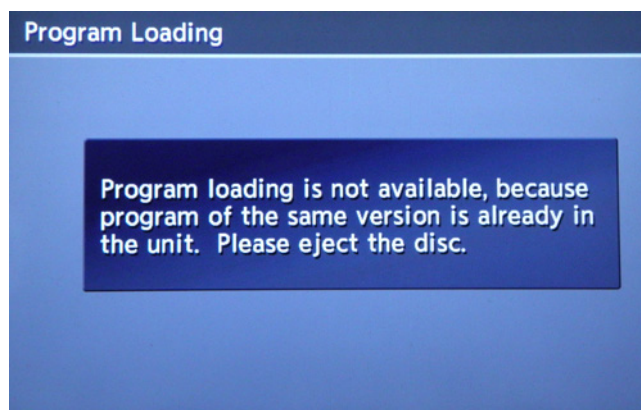
Figure1

- If the screen in Figure 1 is displayed, this update has already been performed and this bulletin does not apply.
  - Turn the Bluetooth back ON and remove the DVD from the CD slot.

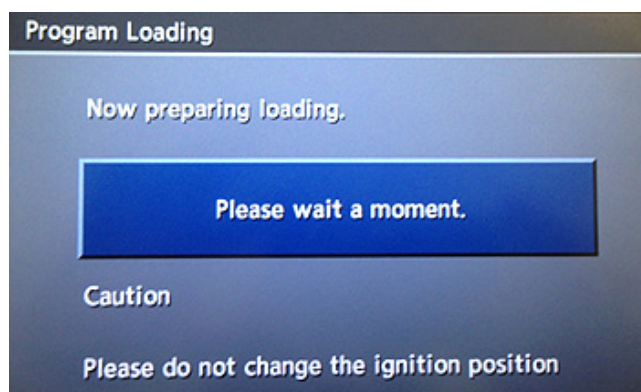
- If “Now preparing loading” shown in Figure 2 is displayed, follow the on screen Caution while the Navigation is updated.

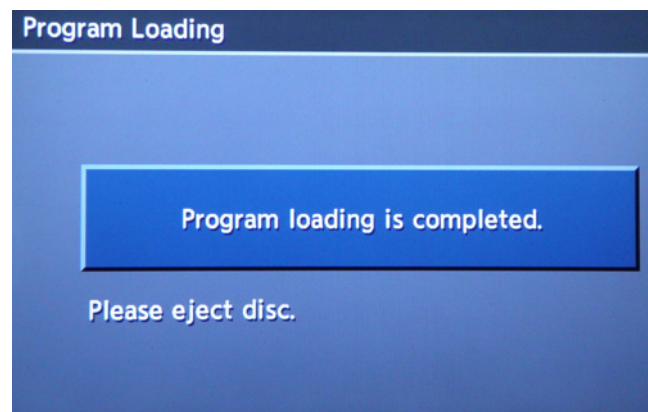
Figure 6

8. When the first part of the program has finished loading:
- "Program loading is completed" will be display (Figure 6).
  - The Reprogramming Software DVD will automatically eject.
9. Remove the DVD and continue to the second part of the update in step 10.

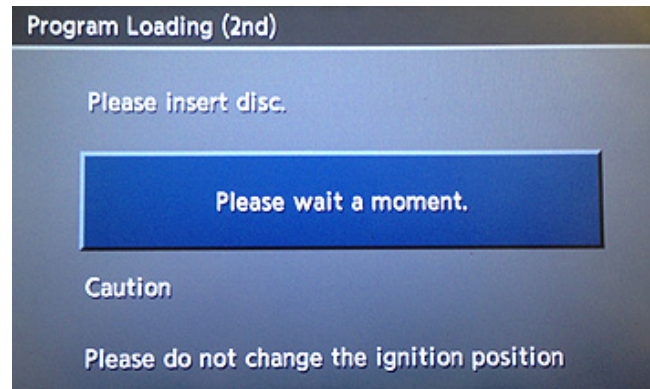
10. After the DVD is removed, the screen in Figure 7 "Please insert disc" may ask to reinstall the **same** Reprogramming Software DVD for a second time.

- If not, the reprogramming is complete. Proceed to step 13.
- If so, re-insert DVD disc.
  - At the top of the screen "Program Loading (2nd)" will be displayed.

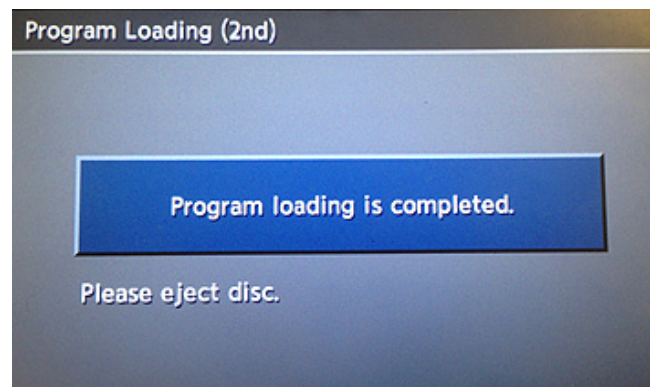
Figure 10

- "Program loading is completed" will be display (Figure 10).
- The Reprogramming Software DVD will automatically eject.
- The Navigation system will restart.
- Proceed to step 13.
