ITB12-053b

January 23, 2013

## **VOLUNTARY SERVICE CAMPAIGN 2013 JX35 METER BACK LIGHT ILLUMINATION AND DISTANCE TO EMPTY INACCURACY**

**CAMPAIGN ID #:** P2538**APPLIED VEHICLE:** 2013 JX35 (L50)

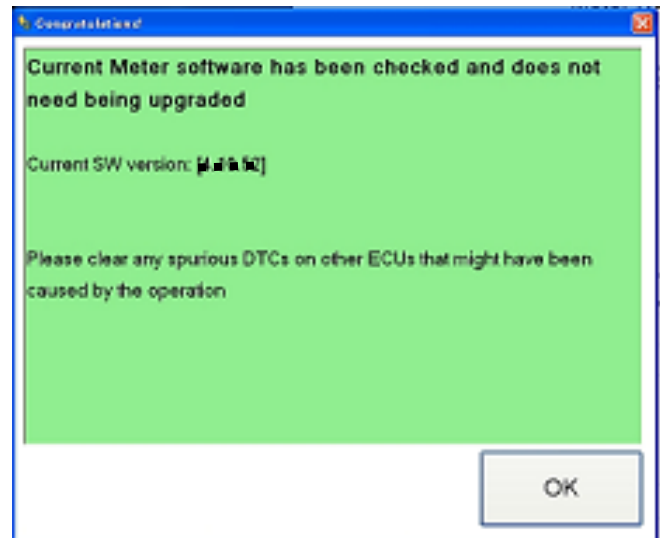
**NOTE:** If the screen in Figure 4 displays, reprogramming is not needed for this vehicle or it has already been done:

- a. Select OK.
- b. Close the reprogramming tool/software.
- c. Skip to step 16.

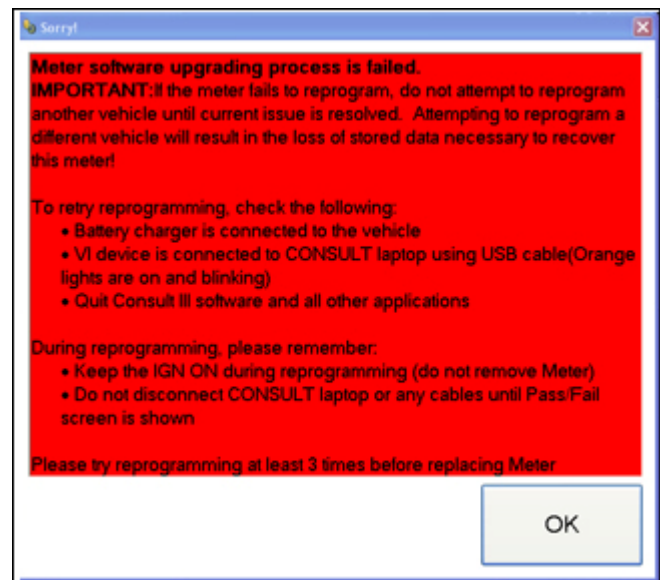
**NOTE:** If the screen in Figure 5 displays:

**Try reprogramming at least 3 more times.**

- a. Select OK and close the reprogramming tool/software.
- b. Restart this Service Procedure from the beginning.
  - **Make sure all steps are completed correctly.**
  - CONSULT software and all other applications are closed.
  - Plus VI is securely connected to the vehicle and USB cable is connected.
  - Battery charger is connected to the vehicle.

**IMPORTANT:** If you get the screen in Figure 5 above:

- Make sure to complete all reprogramming attempts on the current vehicle before moving to another vehicle.
- Using the reprogramming tool on another vehicle will erase all data for the current vehicle, and the meter for the current vehicle will not be reprogrammable (recoverable).
