# SERVICE BULLETIN

Classification: EC12-028a	Reference: NTB12-093a	Date: January 25, 2013
------------------------------	--------------------------	---------------------------

## 2009-2013 MAXIMA, ALTIMA; HARD TO START WHEN AMBIENT TEMPERATURE IS NEAR FREEZING

**APPLIED VEHICLES:** 2009-2013 Maxima (A35) **with VQ35 only**  
 2009-2012 Altima Coupe (CL32) **with VQ35 only**  
 2009-2012 Altima Sedan (L32) **with VQ35 only**

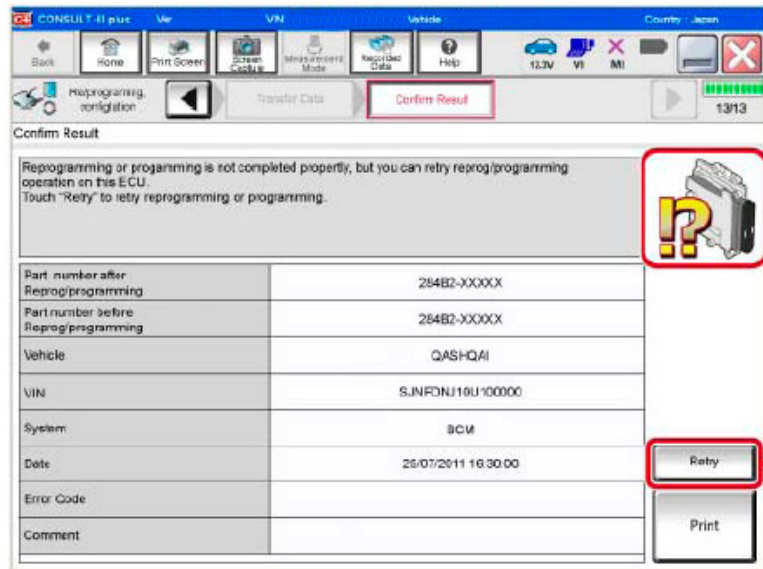
Figure 5

If reprogramming does not complete and the “!?” icon displays as shown in Figure 5:

- Check battery voltage (12.0–15.5 V).
- Ignition is ON, engine OFF.
- External Bluetooth® devices are OFF.
- All electrical loads are OFF.
- **Select retry and follow the on screen instructions.**
- “Retry” may not go through on first attempt and can be selected more than once.

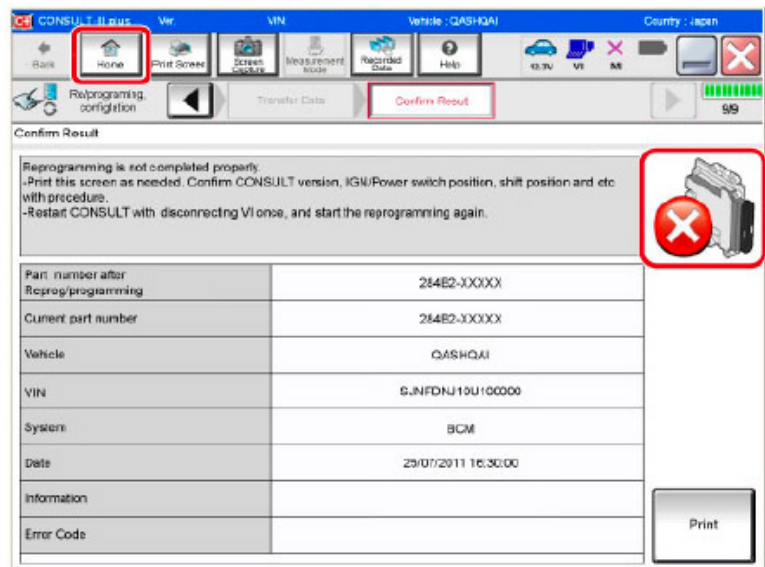
Figure 6

If reprogramming does not complete and the “X” icon displays as shown in Figure 6:

- Check battery voltage (12.0 – 15.5 V).
- CONSULT A/C adapter is plugged in.
- Ignition is ON, engine OFF.
- Transmission is in Park.
- All C-III plus / VI cables are securely connected.
- All C-III plus updates are installed.
- **Select Home, and restart the reprogram procedure from the beginning.**
