# SERVICE BULLETIN

Classification: EL12-050a	Reference: NTB12-097a	Date: February 7, 2013
------------------------------	--------------------------	---------------------------

## 2013 ALTIMA SEDAN; AUDIO MODE ISSUES / XM “LOADING” SOFTWARE UPDATE

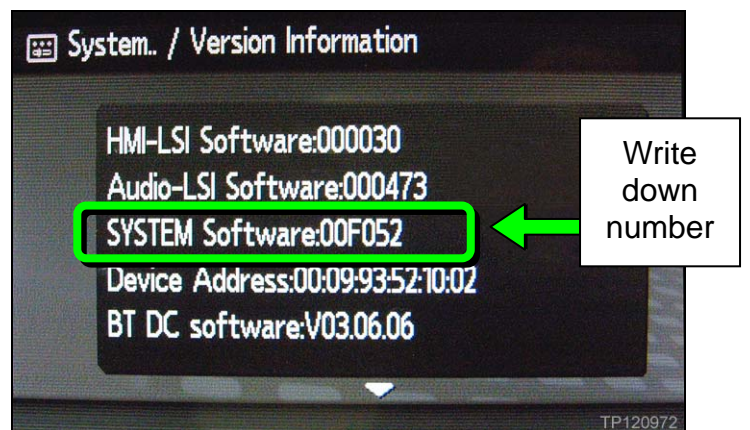
Figure 6

10. Check the **SYSTEM Software** version.

Is the version **00F062**?

Write down the version number and proceed to step 11.

This TSB does not apply. Refer to ASIST for further diagnostic information.

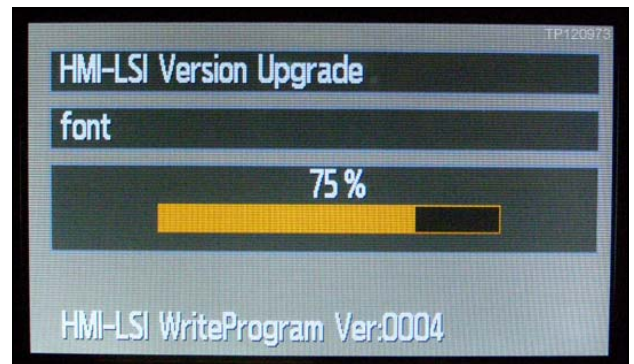
Figure 7

- The screen will display the progress of four updates:

- “Program” – Up to 3 minutes
- “HMI data (icon)” – Up to 40 minutes
- “font” – Up to 20 minutes
- “All Software” – Up to 4 minutes

13. Wait for the software update to complete (may take up to 75 minutes).

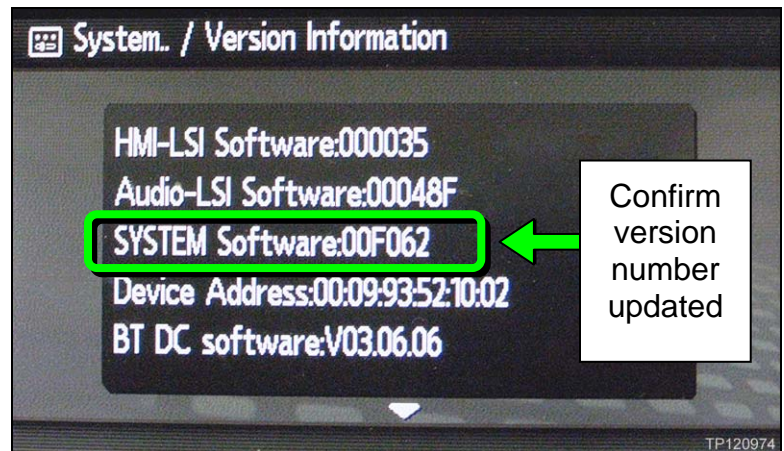
Figure 8

b. Verify the SYSTEM Software version number is **00F062**.
