# SERVICE BULLETIN

Classification: FA99-001a	Reference: NTB99-001a	Date: March 19, 2013
------------------------------	--------------------------	-------------------------

## STRUT AND SHOCK ABSORBER REPLACEMENT GUIDELINES

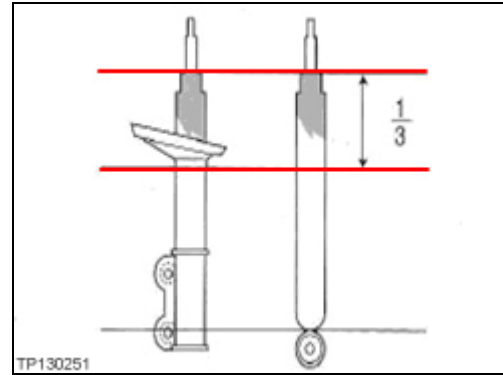
Figure 1

If oil does NOT extend beyond the spring seat or upper 1/3 of shock:

- This is **slight oil seepage**. The strut/shock absorber should NOT be replaced.

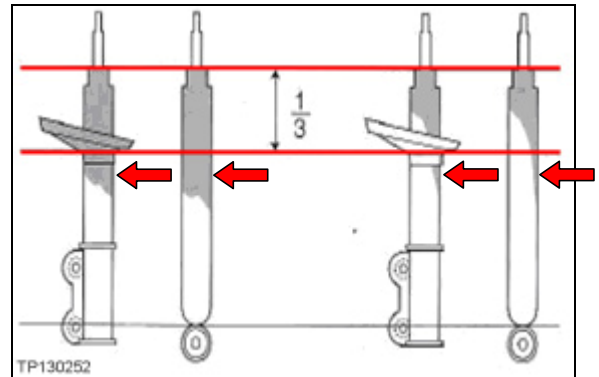
Figure 2

If oil does extend beyond the spring seat or upper 1/3 of shock:

- Use a finger to touch the oil that has extended beyond the spring seat or upper 1/3 of shock.

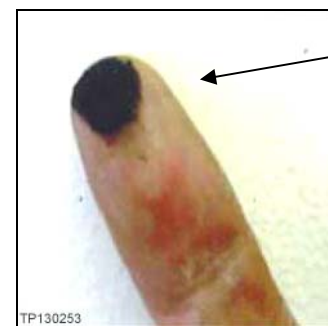
Figure 3

- If you confirm the oil layer is thick and contains large pieces of dust and debris, the strut/shock absorber **should be replaced**.

Thick oil layer,  
large pieces  
of dust and  
debris

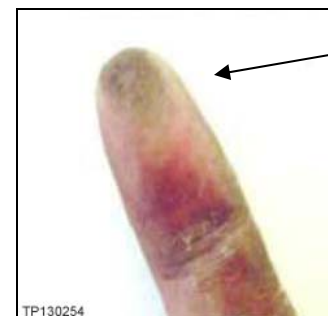
Figure 4

- If you confirm the oil layer is thin and does NOT contain large pieces of dust and debris, the strut/shock absorber should NOT be replaced.

Thin oil layer,  
no large pieces  
of dust and  
debris
