SERVICE CAMPAIGN BULLETIN

NTB13-020

VOLUNTARY SERVICE CAMPAIGN 2013 ALTIMA SEDAN WITH V6 ENGINE; AIR FUEL SENSOR

CAMPAIGN ID #: PC218

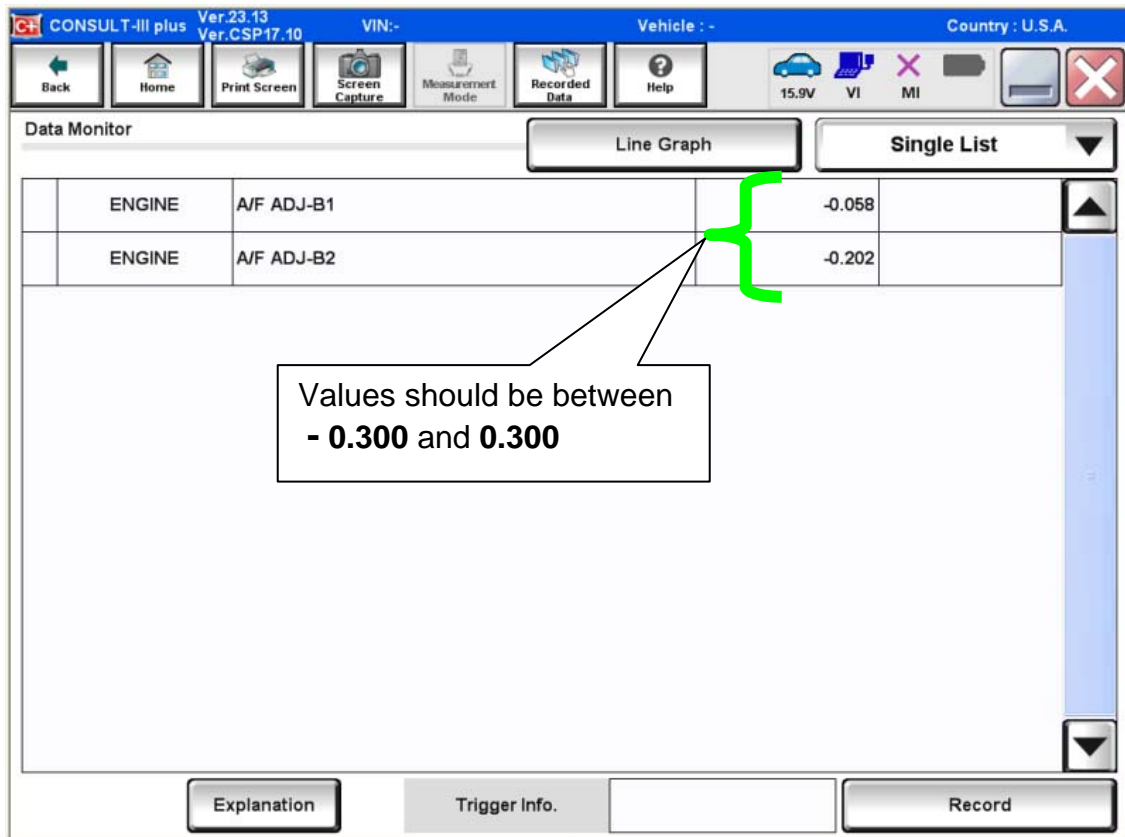
Figure A5

10. Check values for **A/F ADJ-B1** and **A/F ADJ-B2**.

- Value for each sensor should be between **- 0.300** and **0.300**.
- If a sensor (one or both) is out of the above specified range, make a note of it.
- Sensor(s) that are out of the specified value will be replaced later in this procedure.

DO NOT replace A/F sensors at this time.

If needed, replace A/F sensors after ECM reprogramming.

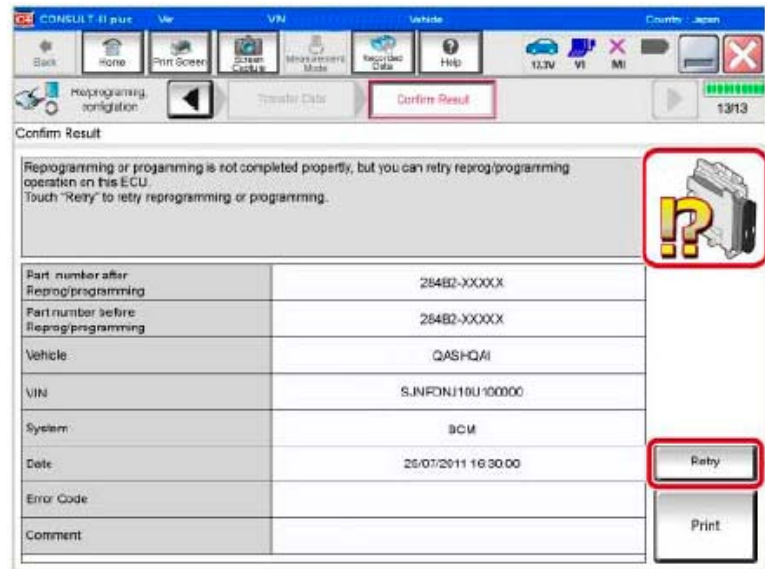
Figure 6

If reprogramming does not complete and the “!?” icon displays as shown in Figure 6:

- Check battery voltage (12.0–15.5 V)
- Ignition is ON, engine OFF
- External Bluetooth® devices are OFF
- All electrical loads are OFF
- **Select retry and follow the on screen instructions**
- “Retry” may not go through on first attempt and can be selected more than once

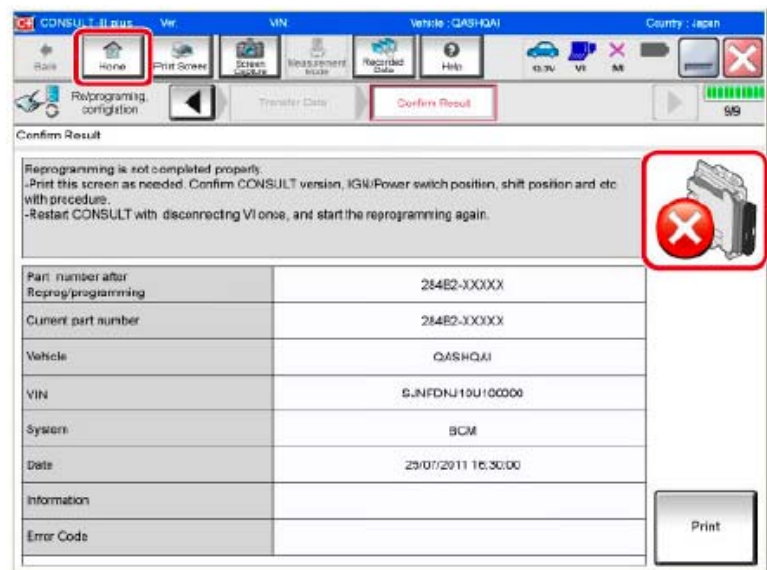
Figure 7

If reprogramming does not complete and the “X” icon displays as shown in Figure 7:

- Check battery voltage (12.0 – 15.5 V)
- CONSULT A/C adapter is plugged in
- Ignition is ON, engine OFF
- Transmission is in Park
- All C-III plus / VI cables are securely connected
- All C-III plus updates are installed
- **Select Home, and restart the reprogram procedure from the beginning**
