Dealer Inventory Inspection

April 12, 2013

2013 Nissan Pathfinder Roof Rail End Cover

Subject: **2013 Nissan Pathfinder Roof Rail End Cover
Dealer Inventory Inspection**

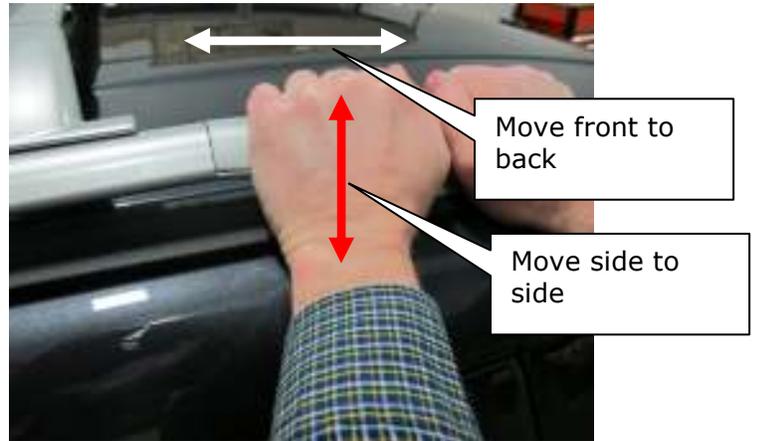
Figure 1

1. Attempt to move or twist roof rail end cover using mild force as shown in Figures 1 and 2.

- Move front to back: Grasp roof rail end cover and attempt to slide it forward/backward.
- Move side to side: Grasp roof rail end cover and attempt to move it inboard/outboard.
- Twist: Grasp roof rail end cover and attempt to rotate it.

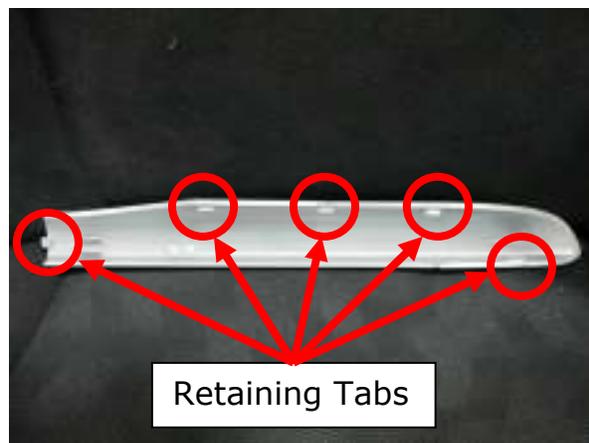
Figure 3

Note: The roof rail end covers have five retaining tabs as indicated in Figure 3.

- Inspect roof rail end cover retaining tabs. If one or more of the roof rail retaining tabs is missing or separated, take a close-up picture of the affected roof rail end cover retaining tabs/s.

4. Send E-mail with attached close-up picture of the missing or separated retaining tab to the below e-mail address for further instructions:
