SERVICE BULLETIN

Classification: EC13-007	Reference: NTB13-054	Date: May 16, 2013
-----------------------------	-------------------------	-----------------------

2013 ALTIMA SEDAN; ENGINE STOPS ON ACCELERATION FROM A STOP AFTER 15 MINUTE IDLE, OR AFTER REFUELING

APPLIED VEHICLE: 2013 Altima Sedan (L33) with QR25DE (4-cyl) engine **ONLY**

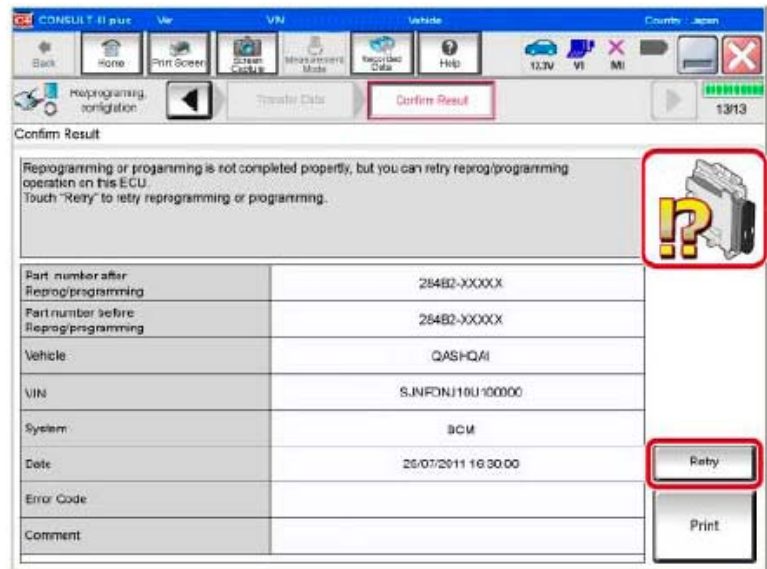
Figure 5

If reprogramming does not complete and the “!” icon displays as shown in Figure 5:

- Check battery voltage (12.0 - 15.5 V).
- Ignition is ON, engine OFF.
- External Bluetooth® devices are OFF.
- All electrical loads are OFF.
- **Select retry and follow the on screen instructions.**
- “Retry” may not go through on first attempt and can be selected more than once.

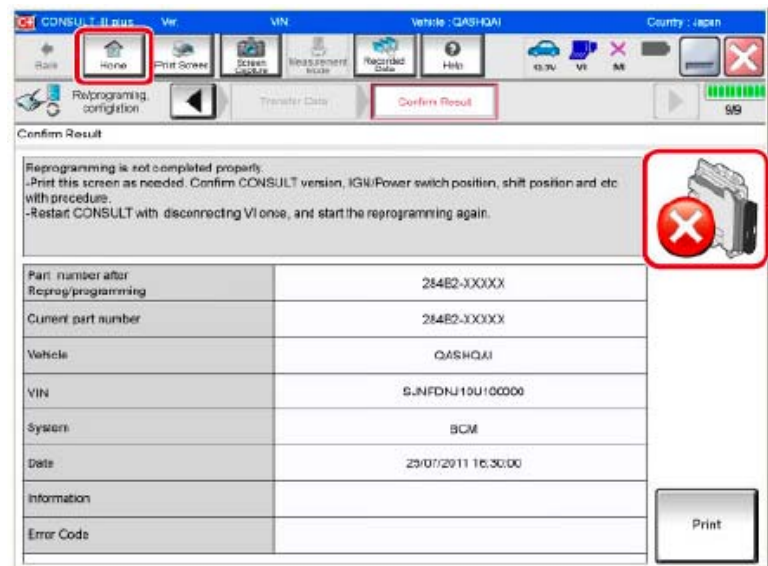
Figure 6

If reprogramming does not complete and the “X” icon displays as shown in Figure 6:

- Check battery voltage (12.0 - 15.5 V).
- CONSULT A/C adapter is plugged in.
- Ignition is ON, engine OFF.
- Transmission is in Park.
- All C-III plus / VI cables are securely connected.
- All C-III plus updates are installed.
- **Select Home, and restart the reprogram procedure from the beginning.**
