SERVICE BULLETIN

Classification: AT13-005	Reference: NTB13-059	Date: May 30, 2013
-----------------------------	-------------------------	-----------------------

2013 ALTIMA SEDAN AND PATHFINDER MIL "ON" WITH DTC P062F

APPLIED VEHICLES: 2013 Altima Sedan (L33)
2013 Pathfinder (R52)

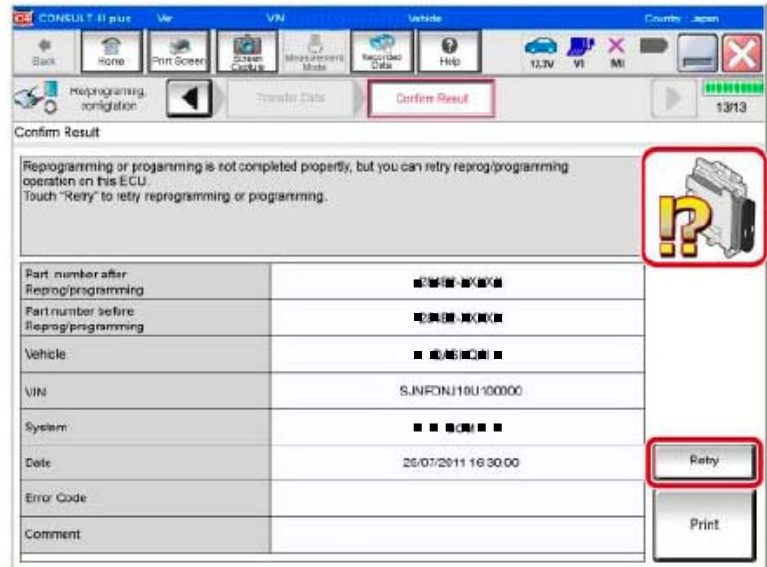
Figure 5

If reprogramming does not complete and the “!?” icon displays as shown in Figure 5:

- Check battery voltage (12.0–15.5 V).
- Ignition is ON, engine OFF.
- External Bluetooth® devices are OFF.
- All electrical loads are OFF.
- **Select retry and follow the on screen instructions.**
- “Retry” may not go through on first attempt and can be selected more than once.
