SERVICE CAMPAIGN BULLETIN

NTB13-022a

VOLUNTARY SERVICE CAMPAIGN 2013 SENTRA COLD IDLE ECM AND TCM REPROGRAM

CAMPAIGN ID #: P3212

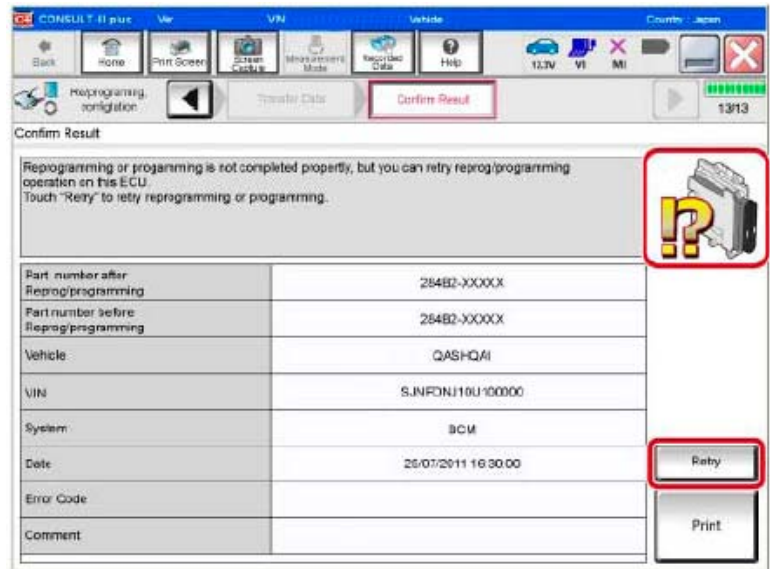
Figure 5

If reprogramming does not complete and the “!?” icon displays as shown in Figure 5:

- Check battery voltage (12.0–15.5 V).
- Ignition is ON, engine OFF.
- External Bluetooth® devices are OFF.
- All electrical loads are OFF.
- **Select retry and follow the on screen instructions.**
- “Retry” may not go through on first attempt and can be selected more than once.

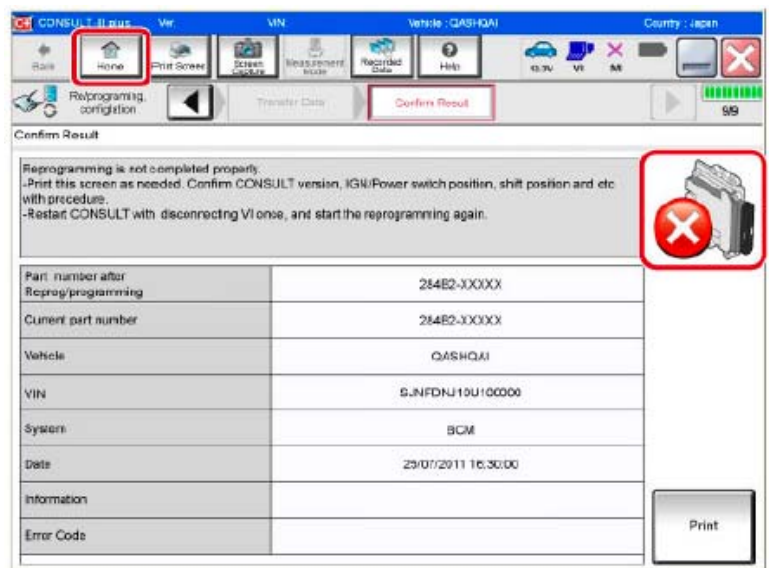
Figure 6

If reprogramming does not complete and the “X” icon displays as shown in Figure 6:

- Check battery voltage (12.0 – 15.5 V).
- CONSULT A/C adapter is plugged in.
- Ignition is ON, engine OFF.
- Transmission is in Park.
- All C-III plus / plus VI cables are securely connected.
- All C-III plus updates are installed.
- **Select Home, and restart the reprogram procedure from the beginning.**
