# SERVICE BULLETIN

Classification: EC13-003a	Reference: NTB13-021a	Date: July 2, 2013
------------------------------	--------------------------	-----------------------

## 2010-2012 FRONTIER, PATHFINDER AND XTERRA; VIBRATION WHILE IDLING

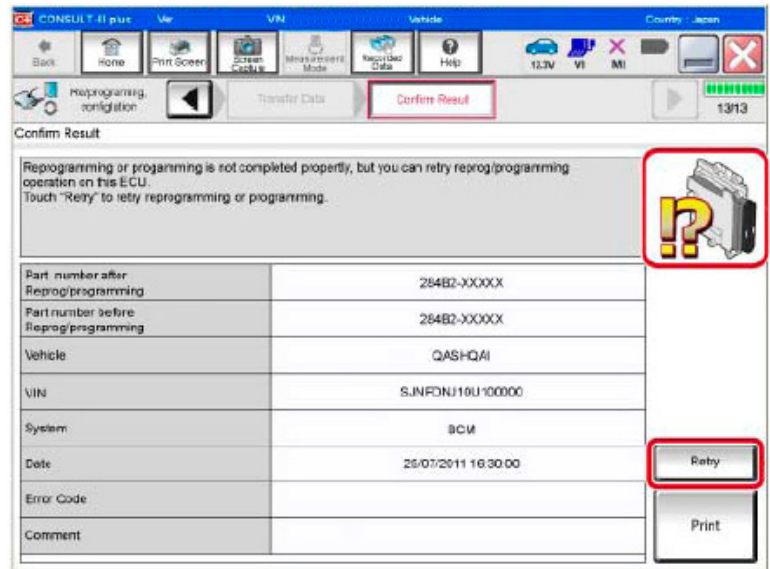
Figure 5

If reprogramming does not complete and the “!” icon displays as shown in Figure 5:

- Check battery voltage (12.0–15.5 V).
- Ignition is ON, engine OFF.
- External Bluetooth® devices are OFF.
- All electrical loads are OFF.
- **Select retry and follow the on screen instructions.**
- “Retry” may not go through on first attempt and can be selected more than once.

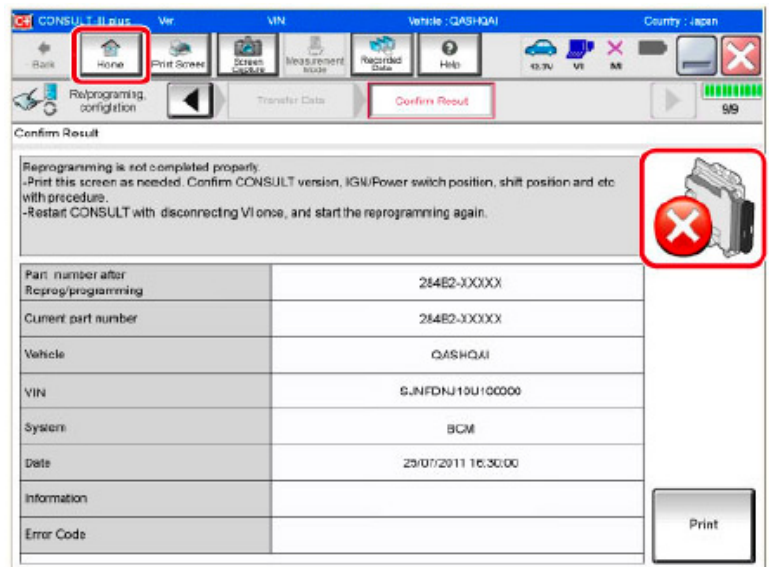
Figure 6

If reprogramming does not complete and the “X” icon displays as shown in Figure 6:

- Check battery voltage (12.0 – 15.5 V).
- CONSULT A/C adapter is plugged in.
- Ignition is ON, engine OFF.
- Transmission is in Park.
- All C-III plus / VI cables are securely connected.
- All C-III plus updates are installed.
- **Select Home, and restart the reprogram procedure from the beginning.**
