SERVICE BULLETIN

Classification: EL13-022	Reference: NTB13-067	Date: July 3, 2013
-----------------------------	-------------------------	-----------------------

2013 ARMADA; COMFORT AND CONVENIENCE SETTINGS MISSING

APPLIED VEHICLE: 2013 Armada (TA60) equipped with Navigation **ONLY**

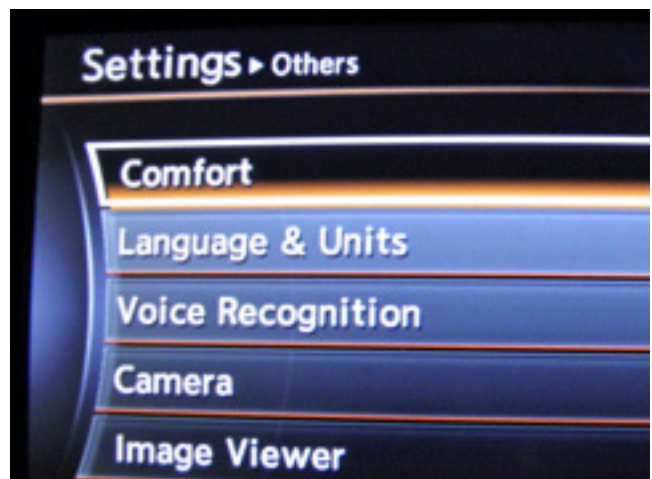
Figure A

The “Comfort” option (comfort & convenience settings) under the Navigation’s user configurable settings is missing from the scroll down menu, which includes:

- Auto Interior Illumination
- Light Sensitivity
- Light Off Delay
- Speed Sensing Wiper Interval
- Selective Door Unlock
- Intelligent Key Lock/Unlock
- Slide Driver’s Seat Back on Exit
- Return all Settings to Default

1. Follow the Service Procedure starting on page 2 to load the Re-programming Software DVD referenced in the Parts Information on the next page.
2. Initialize and then manually configure the MULTI AV system with the setting in this bulletin.

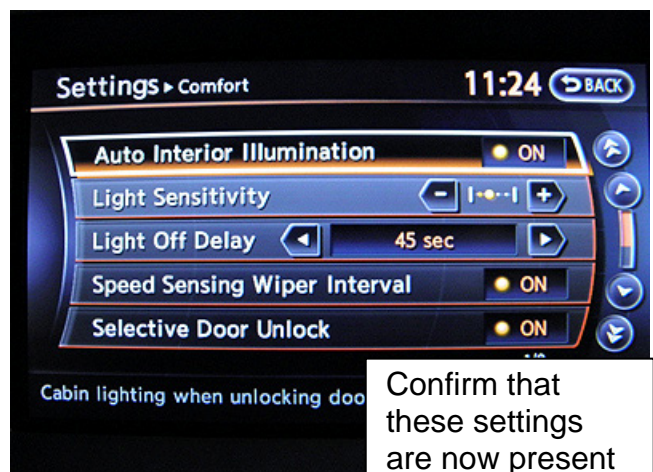
Figure 28

1. Confirm that Settings>Others>Comfort options, under the Navigation's user configurable settings, are now present.
