# SERVICE CAMPAIGN BULLETIN

NTB13-052b

## VOLUNTARY SERVICE CAMPAIGN 2013 ALTIMA SEDAN HEATED SEATS

**APPLIED VEHICLE:** 2013 Altima Sedan (L33)

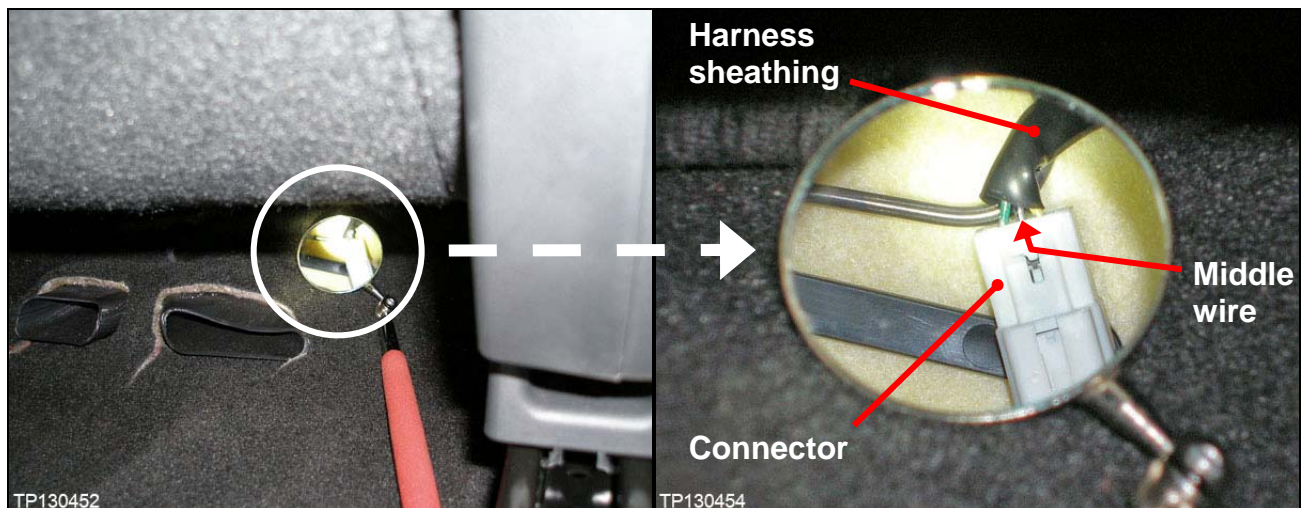
Figure 1; seat viewed from bottom rear

1. Move both front seats fully forward, and then adjust the seatbacks forward.
2. From the rear of the front seats using a mirror and flashlight, locate the white 3-wire harness connector under the seat frame assemblies of BOTH front seats (see Figure 1).
  - Look **ONLY** at the side of the white connector where the wire colors are green, yellow, and black.
  - **IGNORE** the wires on the other side of the white connector.
  - The harness sheathing may need to be pulled back for good viewing.
  - See next page for a detailed picture.

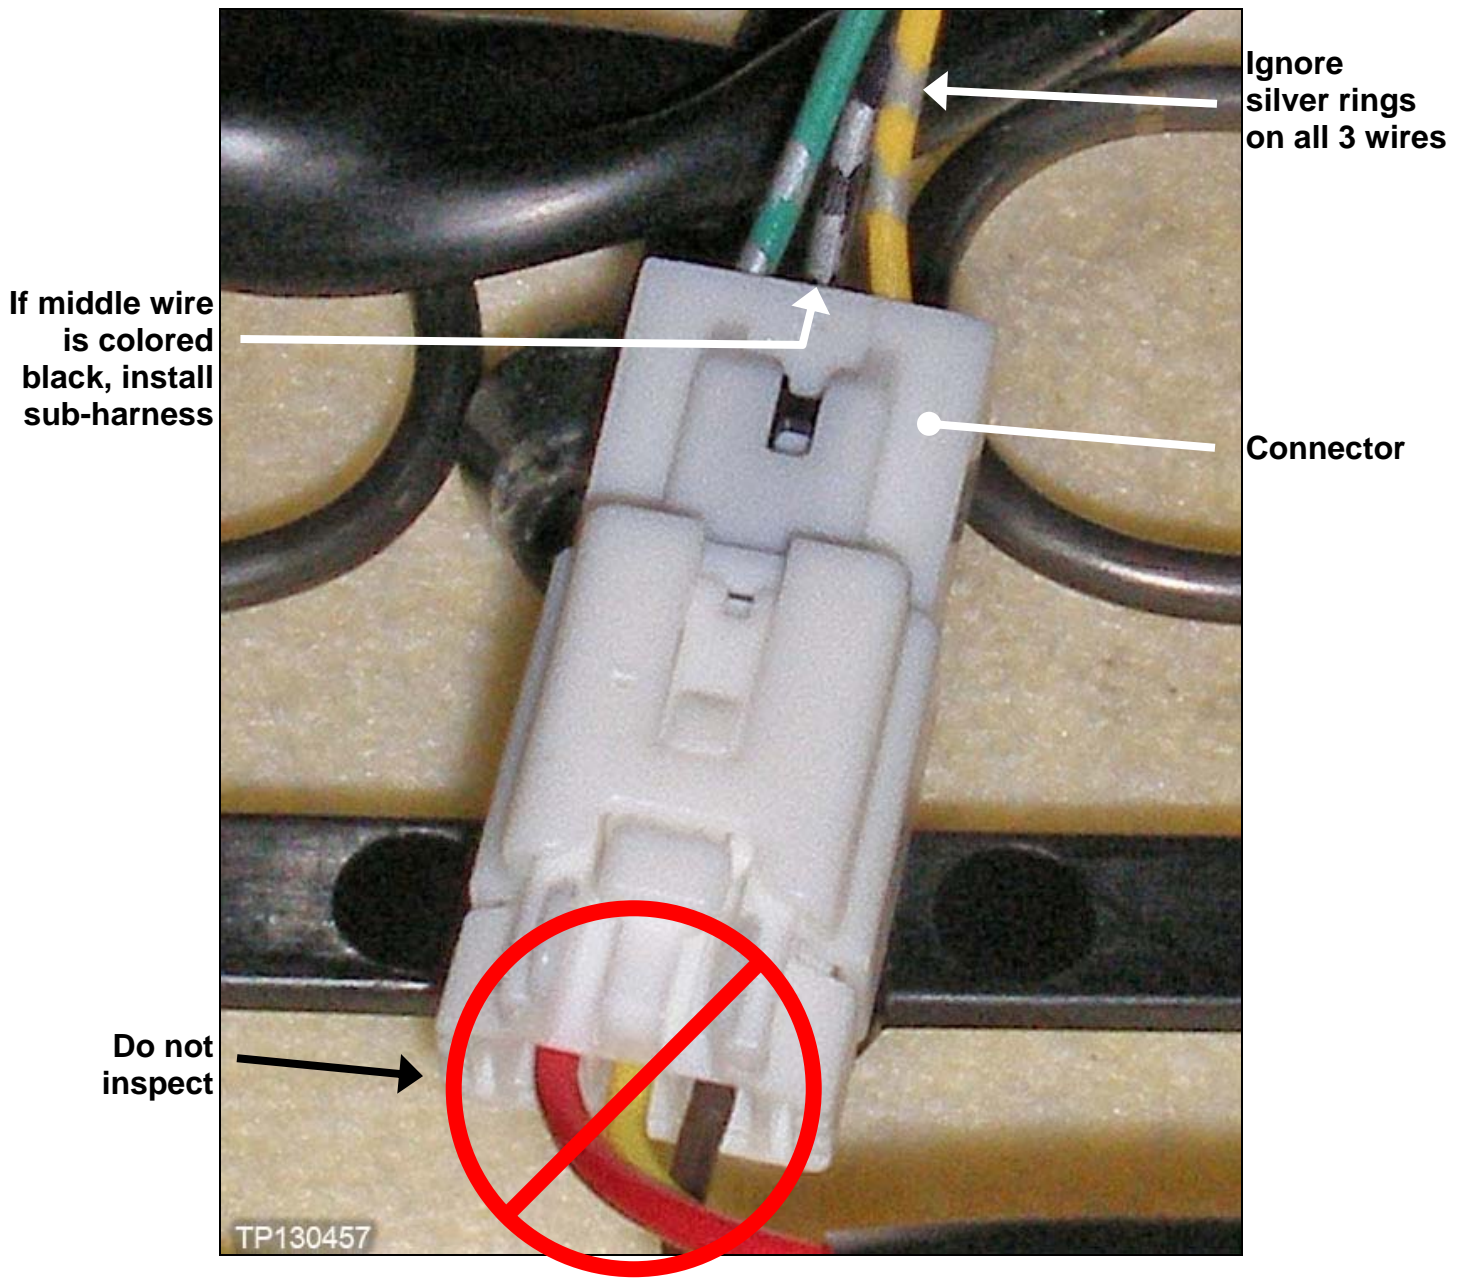
Figure 3; picture taken with seat lifted for easier viewing only.

3. For seats where the middle wire is black (see Figure 3): Install a sub-harness listed in **PARTS INFORMATION**.
  - Go to **Install Sub-harness(es)** on the next page.
4. When the middle wire is NOT black on BOTH seats: No further work is needed. Go to **CLAIMS INFORMATION**.
