SERVICE BULLETIN

Classification: EL13-025	Reference: NTB13-070	Date: July 17, 2013
-----------------------------	-------------------------	------------------------

2013 ALTIMA SEDAN AND PATHFINDER; INTELLIGENT KEY REGISTRATION CANNOT COMPLETE

APPLIED VEHICLES: 2013 Altima Sedan (L33)
2013 Pathfinder (R52)

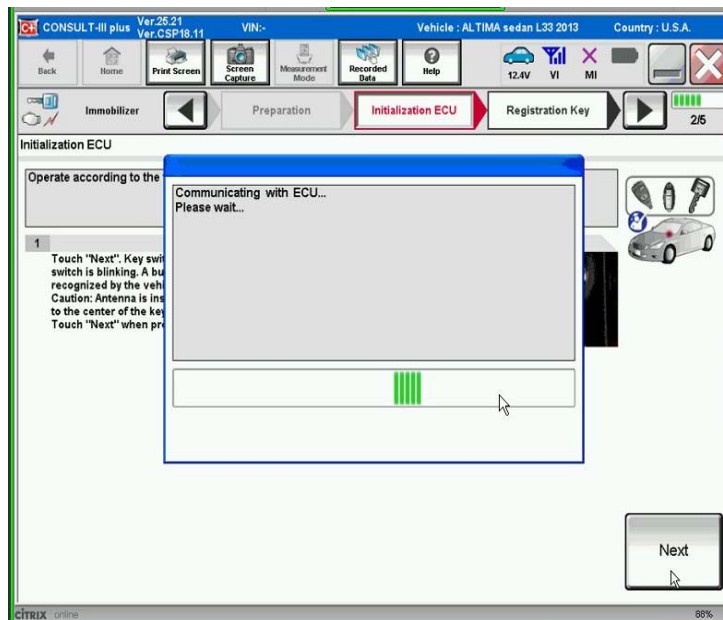
Figure 1

- the first registration attempt is unsuccessful, AND
- during the next registration attempt, CONSULT-III plus becomes hung up / stuck (see Figure 1) prior to the pre-PIN read step and will not allow you to proceed.

Perform the additional steps, beginning on page 2, to restart the procedure.

2. Disconnect the negative cable from the vehicle battery.

3. Wait 30 seconds, then reconnect the negative cable to the vehicle battery.

4. Perform Intelligent Key Registration procedure.
