# SERVICE BULLETIN Classification: BR04-007a Reference: NTB04-094a July 23, 2013

## NISSAN; ON-CAR BRAKE ROTOR RESURFACING

**APPLIED VEHICLES:** All Nissan

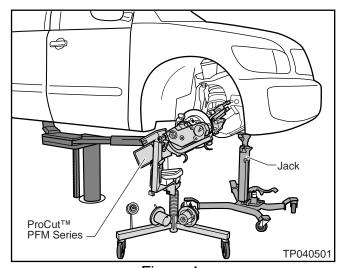
Figure 1

- B. For best accuracy, "stabilize" (firmly support) the vehicle with a jack or jack stand as shown in Figure 1.
  - On some hoists, the vehicle may "wobble" a little while using the on-car brake lathe. <u>Not good</u>.

**CAUTION:** Any rocking motion (wobble) of the vehicle during the ProCut<sup>™</sup> "automatic compensation" procedure will reduce the accuracy of the resurfacing.

If wobble occurs during the rotor resurfacing process/procedure, the finished rotor runout may be more than factory specification and should be checked before using the rotor.
