# SERVICE BULLETIN

Classification: EL13-029a	Reference: NTB13-068	Date: October 4, 2013
------------------------------	-------------------------	--------------------------

## 2013 ARMADA WITH NON-NAVIGATION SYSTEM; COMFORT SETTING MISSING

**APPLIED VEHICLE:** 2013 Armada (TA60) equipped with Non-Navigation system **ONLY**  
**APPLIED VIN and**

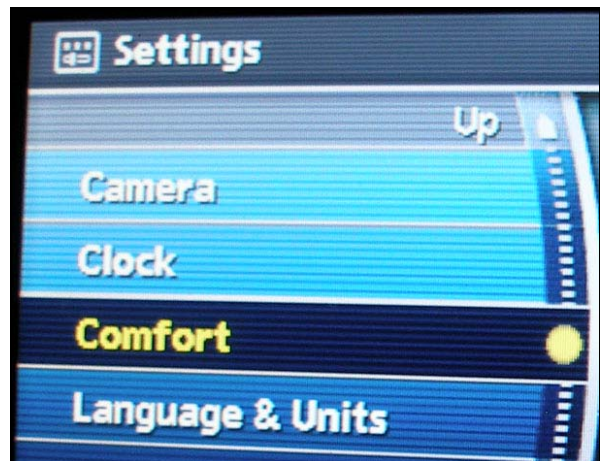
Figure A

The “Comfort” option under the Non-Navigation system’s user configurable settings menu is missing from the scroll down menu, which includes:

- Auto Interior Illumination
- Light Sensitivity
- Light Off Delay
- Speed Sensing Wiper Interval
- Selective Door Unlock
- Return all Settings to Default

1. Follow the **SERVICE PROCEDURE** starting on page 2 to load the Reprogramming Software DVD referenced in **PARTS INFORMATION** on the next page.
2. Read configuration, initialize, and then manually configure the MULTI AV system with the setting in this bulletin.

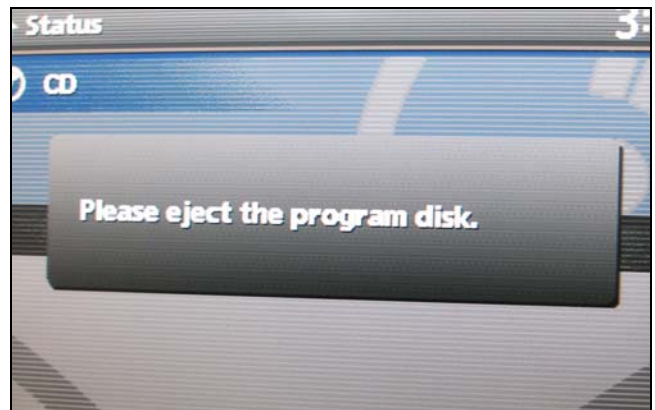
Figure1

- If “Please eject the program disk” in Figure 1 is displayed, this update has already been performed and this bulletin does not apply.
  - Refer to ASIST for further diagnostic information.
  - Remove the DVD from the CD slot.

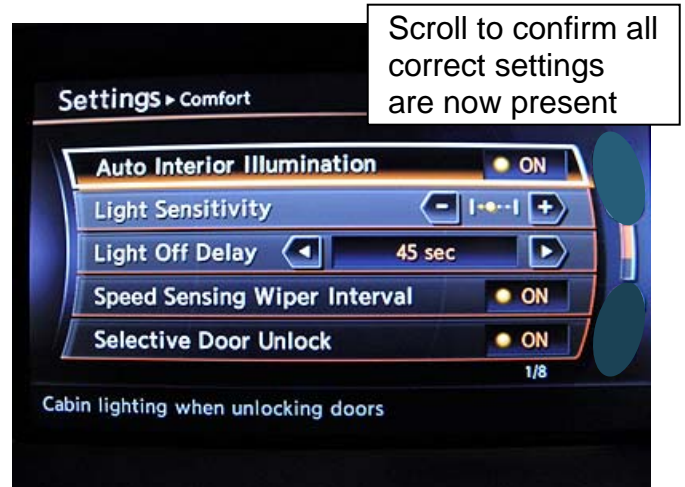
Figure 23

1. Scroll to confirm the following settings are now present in the “Comfort” option:
  - Auto Interior Illumination
  - Light Sensitivity
  - Light Off Delay
  - Speed Sensing Wiper Interval
  - Selective Door Unlock
  - Return all Settings to Default
