SERVICE BULLETIN

EL13-015a NTB13-057a October 23, 2013

2013 - 2014 ALTIMA SEDAN; LANE DEPARTURE WARNING AND BLIND SPOT WARNING SYSTEMS SERVICE INFORMATION

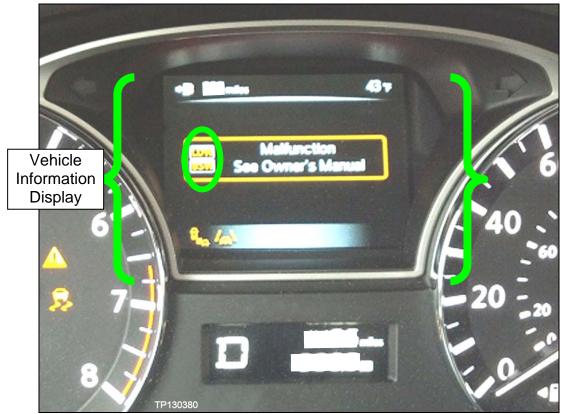
Figure 1

Message "Malfunction – See Owner's Manual" with LDW / BSW icons showing in the Vehicle Information Display (including but not limited to what shows in Figure 1)

If a 2013 or 2014 Altima Sedan is presented with one or more of the following items, perform the Preliminary Checks on the next page.
