# SERVICE BULLETIN

Classification: AT10-010a	Reference: NTB10-150a	Date: November 5, 2013
------------------------------	--------------------------	---------------------------

## 2010 ALTIMA, ROGUE, AND SENTRA MIL IS ON AND/OR SLOWER THAN NORMAL ACCELERATION

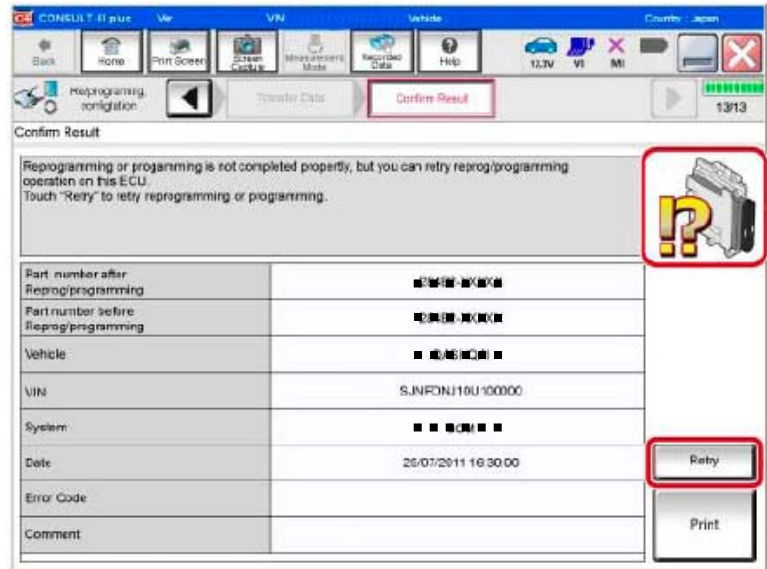
Figure 5

If reprogramming does not complete and the “!?” icon displays as shown in Figure 5:

- Check battery voltage (12.0–15.5 V).
- Ignition is ON, engine OFF.
- External Bluetooth® devices are OFF.
- All electrical loads are OFF.
- **Select retry and follow the on screen instructions.**
- “Retry” may not go through on first attempt and can be selected more than once.

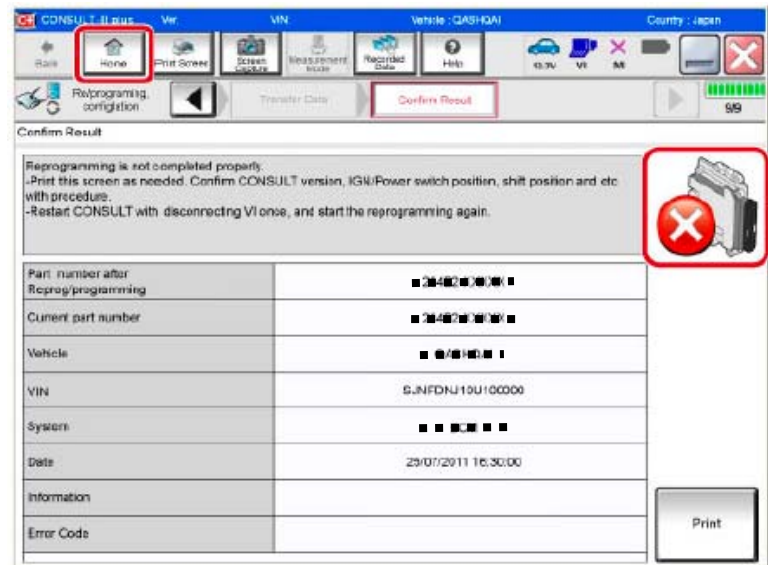
Figure 6

If reprogramming does not complete and the “X” icon displays as shown in Figure 6:

- Check battery voltage (12.0 – 15.5 V).
- CONSULT A/C adapter is plugged in.
- Ignition is ON, engine OFF.
- Transmission is in Park.
- All C-III plus / VI cables are securely connected.
- All C-III plus updates are installed.
- **Select Home, and restart the reprogram procedure from the beginning.**
