SERVICE BULLETIN

Classification: FA12-003a	Reference: NTB12-090a	Date: November 26, 2013
------------------------------	--------------------------	----------------------------

2013 ALTIMA; DRUMMING NOISE IN FRONT SUSPENSION WHEN TURNING

APPLIED VEHICLE: 2013 Altima Sedan (L33)

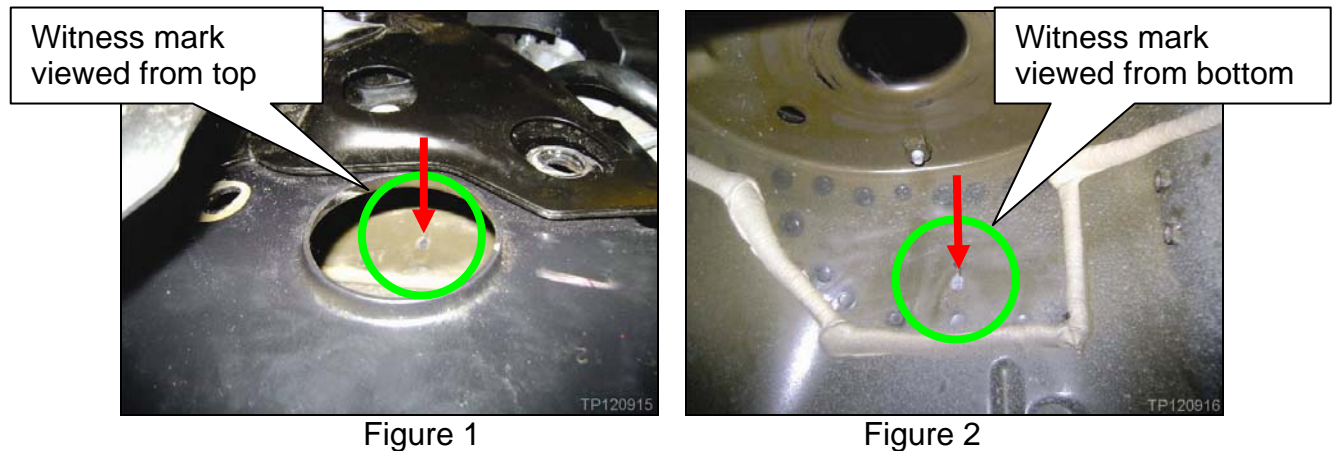
- There is a drumming noise from the right front Strut Tower area when the Steering Wheel is being turned to the left and while moving at under 15 MPH.

- A witness mark is present as shown in Figures 1 and 2 on page 3.

Figure 1 and Figure 2 show witness mark from coil spring. Shown with right front Strut removed for reference only.

1. Remove right side strut assembly from vehicle.
2. Replace strut coil spring with model specific part listed in **PARTS INFORMATION**, above.
3. While strut is out of vehicle, clean witness mark of any rust, corrosion, etc. See Figure 1 and Figure 2 on the next page.

4. Apply Zinc-Rich Primer (see **PARTS INFORMATION**) within 12 mm (approx. ½ inch) on and around the witness mark area; allow to dry.
5. Apply Bitumen Wax (see **PARTS INFORMATION**) within 12 mm (approx. ½ inch) on and around the witness mark area; allow to dry.
 - Follow instructions on the label of Bitumen Wax.
6. Reinstall strut into vehicle.
