# SERVICE BULLETIN

BT13-023
 NTB13-103
 November 26, 2013

## 2013 - 2014 ALTIMA SEDAN; REAR COMBINATION LAMP SCRATCHES PAINT

APPLIED VEHICLE: 2013 - 2014 Altima Sedan (L33)

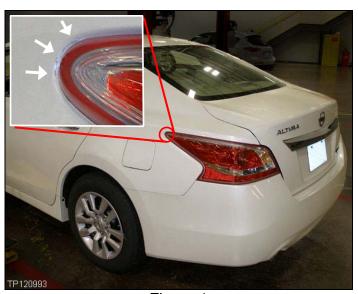
Figure 1

Contact marks on the painted surface of the body are visible anywhere along the forward edges of either rear combination lamp.

- 1. Using standard auto body repair practices, perform a Refinish Half-Block Repair to the area(s) affected by the rear combination lamp(s).
- 2. Apply a piece of protective urethane tape (see **PARTS INFORMATION**) on <u>both</u> sides of the vehicle where shown in the **SERVICE PROCEDURE**.
