******* Dealer Announcement *******

2014 Rogue Rear Liftgate Glass Inspection

Reference: PC255
Date: November 27, 2013

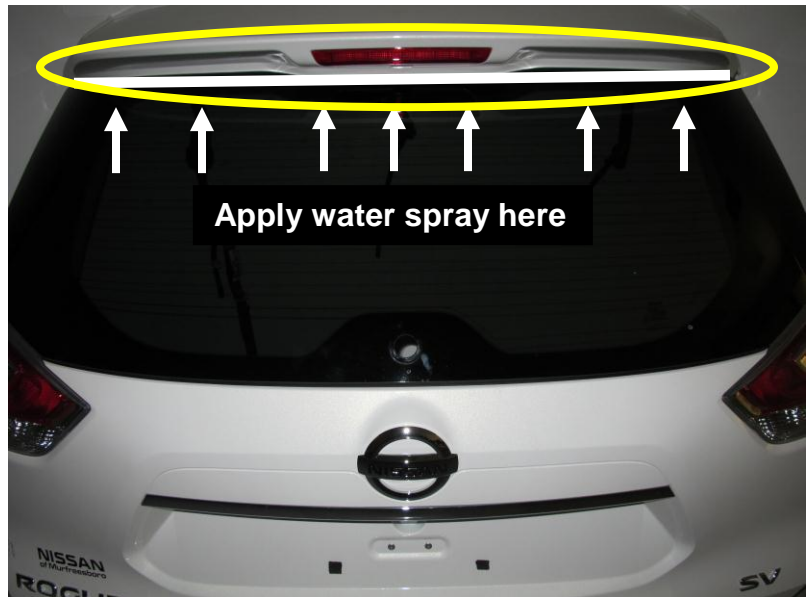
Figure 1

Nissan is conducting a Dealer Service Action to inspect for water leaks at the rear liftgate glass on certain specific 2014 Nissan Rogue vehicles currently in dealer inventory only. On a small percentage of vehicles, the rear liftgate window seal may not meet specifications and may allow water to enter the vehicle.

1. Water leak test the top of rear liftgate glass.
 - Use a garden hose to apply low pressure water spray.
 - Apply water to top of rear liftgate glass for 30 seconds to the area shown in Figure 1.
2. Check for water entry to inside of the vehicle at the top of the rear liftgate glass.

3. If no water entry into the vehicle:
 - Submit warranty claim using Op Code PC2550.(see claims info)
 - Release the vehicle.
4. If water entry into the vehicle is verified at the rear liftgate glass area:
 - Continue to HOLD the vehicle.
 - Send E-mail to the below address for parts planning purposes only:
nafgasupport@nissan-usa.com
