SERVICE BULLETIN

EL13-050

INTELLIGENT KEY NOT DETECTED / ENGINE WILL NOT START

APPLIED VEHICLES: 2013 - 2014 Altima Sedan (L33)
2013 - 2014 Pathfinder (R52)
2014 Pathfinder Hybrid (HR52)
2014 Rogue (T32)

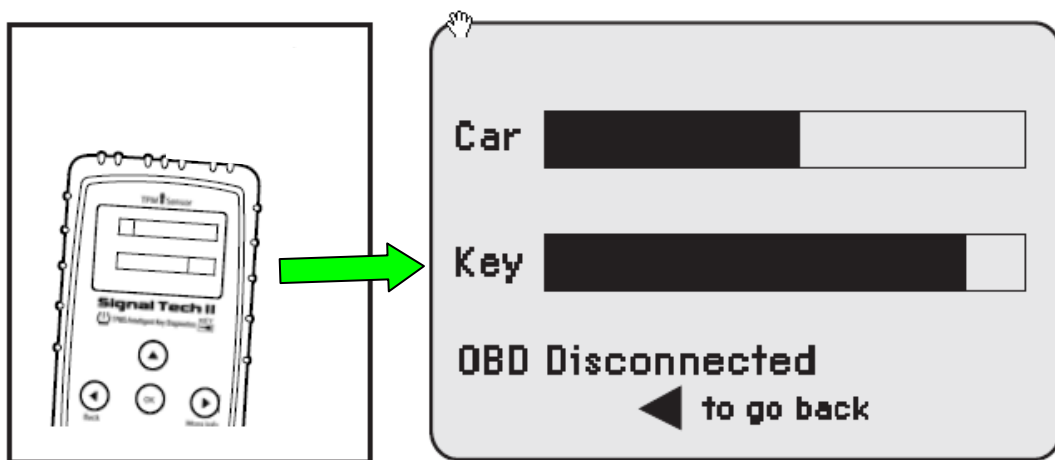
Figure 2

5. Observe the bar graph for **Key**.
 - Ignore the bar graph for **Car**.
 - If a signal is detected in the **Key** bar graph, this may indicate an interference issue. In this case, the source of the interference must be isolated / eliminated.
